March 14, 2016

### *What happened and where?*

On January 25, 2016 a significant rock slide occurred at Gallagher Lake which impacted a siphon on the canal irrigation system which provides irrigation water to the Town of Oliver, Electoral Area C (rural Oliver), and Osoyoos Indian Band. The break is near station 2+055 on the flume section at Gallagher Lake.

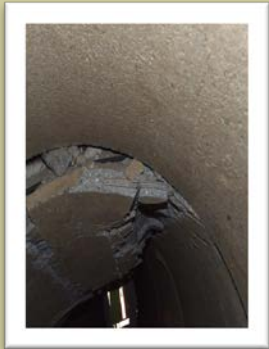
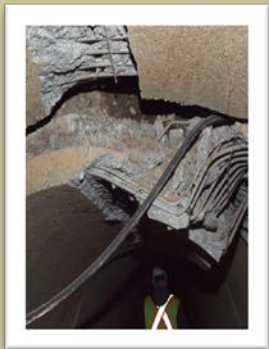
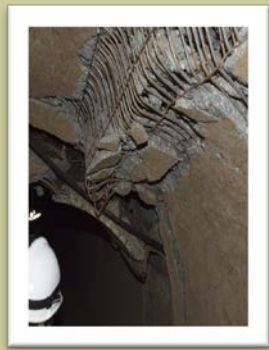
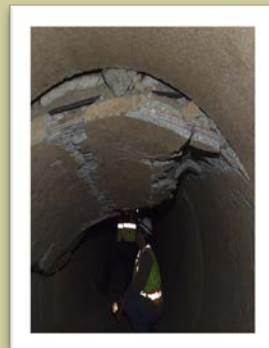
You can see from the pictures the damage is significant to the siphon; the roof has collapsed in one section as much as 2 feet or .61 meters.

This section of siphon was installed in 1997 to help minimize and eliminate damages to the existing canal system. It is a 1950 mm (78”) diameter reinforced concrete pipe buried over with approximately 3 m of fill. It was engineered to withstand a great force if more debris were to fall. The fill was unable to withstand the force and direct damage occurred.

Based on the visual analysis the best temporary option for repair is to insert 2 sleeves inside the siphon. This is a temporary solution for the irrigation season and cannot guarantee a 100% fix if there are more damages or settlement.
