## Facility Condition Assessment Report Oliver Community Centre & Pool 665 McKinney Road Oliver, BC

Submitted to:  
Oliver Parks and Recreation Society  
PO Box 627  
Oliver, BC V0H 1T0  
Attention: Carol Sheridan, Manager of Recreation

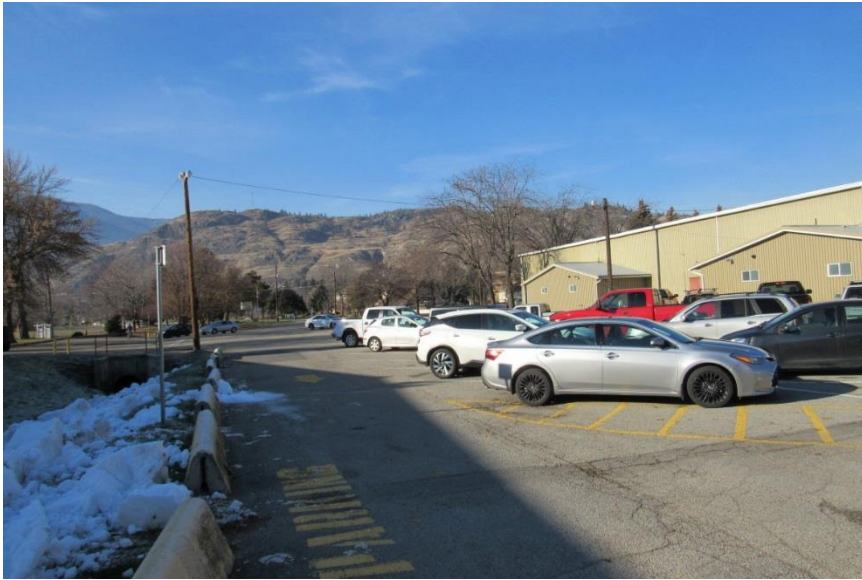
**Photo #A1:** General view of the asphalt parking lot.

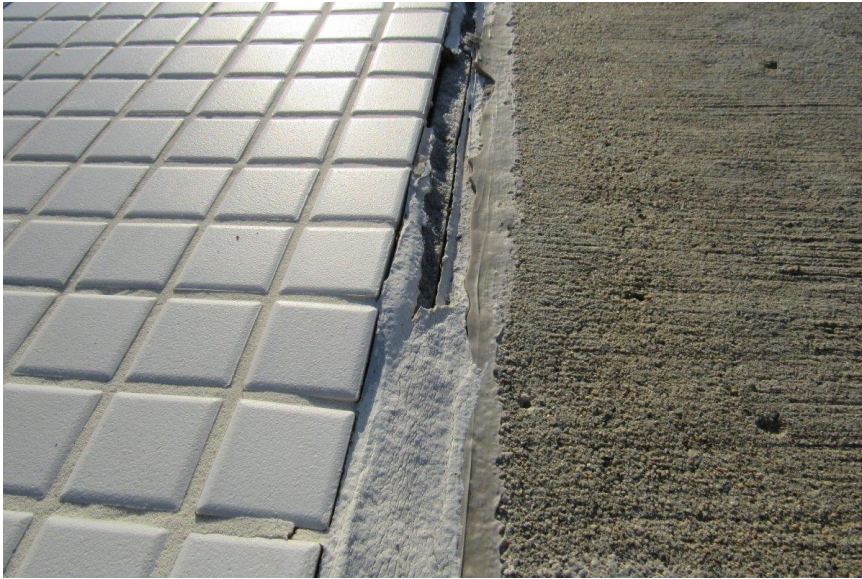
**Photo #S7:** Cracks at Pool Deck.

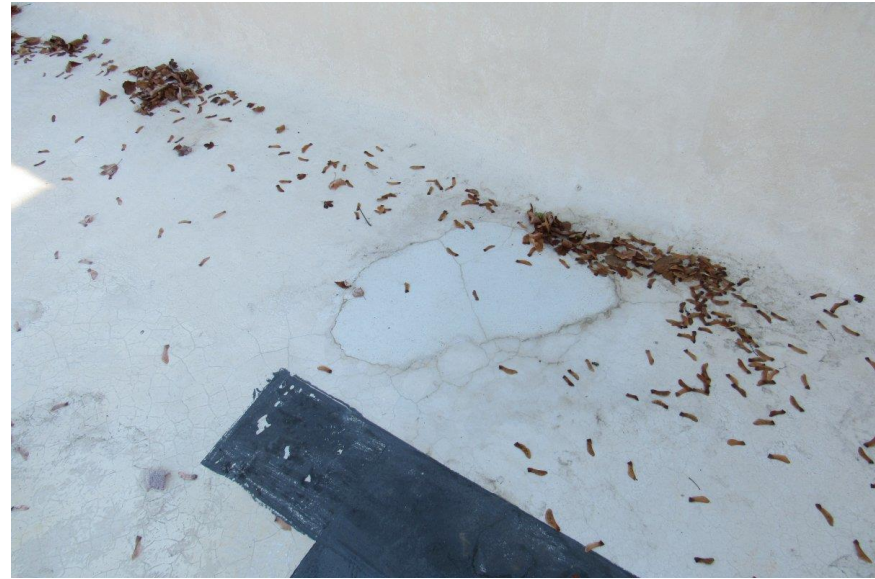
**Photo #S8:** Cracked Pool Basin.

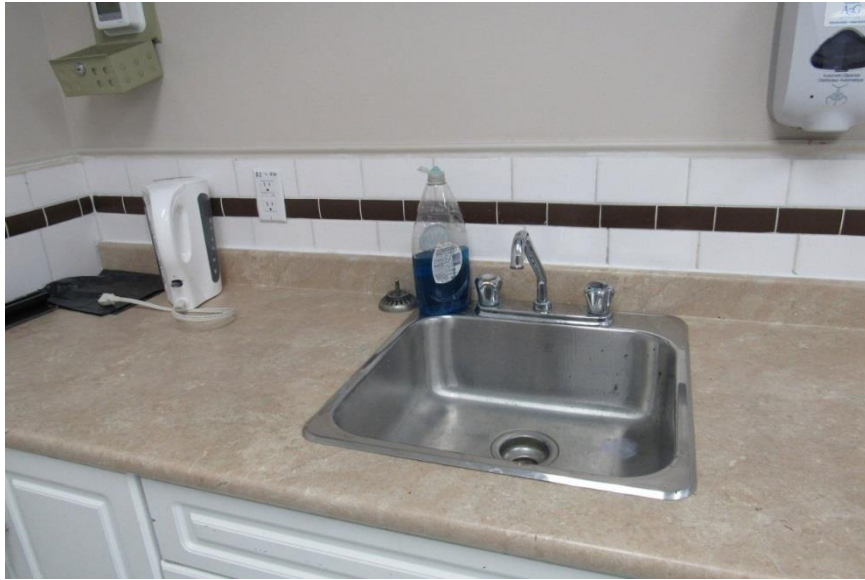
**Photo #M5:** Counter-mounted stainless-steel sink.

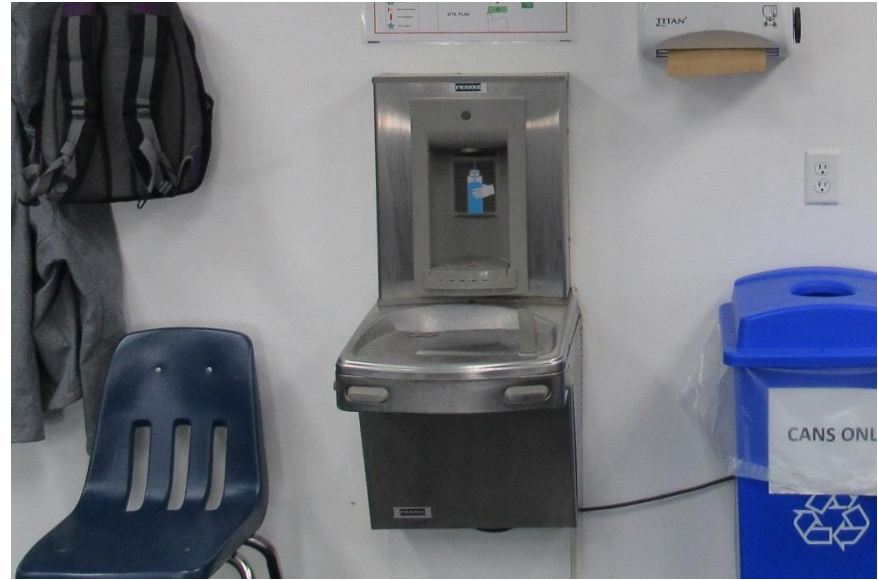
**Photo #M6:** Drinking fountain at the Community Centre.

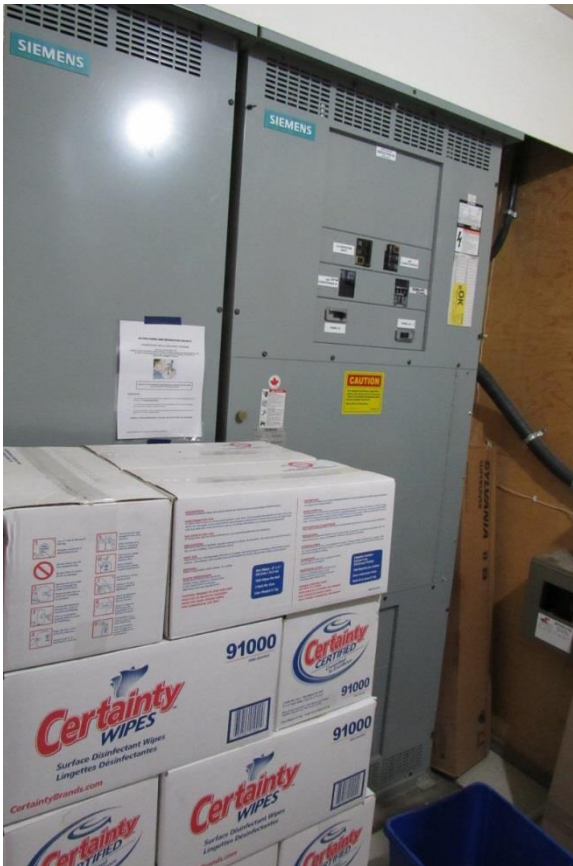
**Photo #E1:** Primary electrical panelboard at the Community Centre.

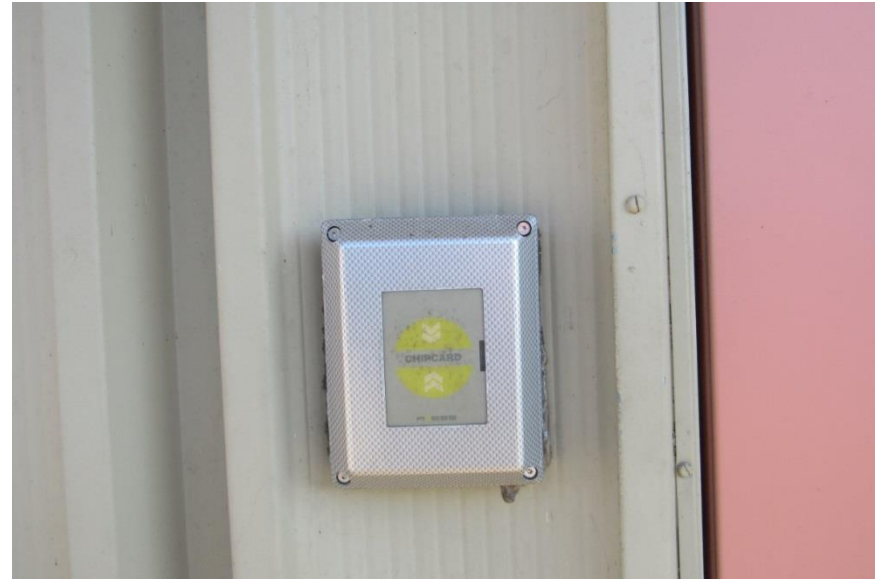
**Photo #E10:** Proximity card reader at the Community Centre.
