## FINAL REPORT

# Facility Lifecycle Assessment Report Oliver and District Arena 665 Mc Kinney Road Oliver, British Columbia

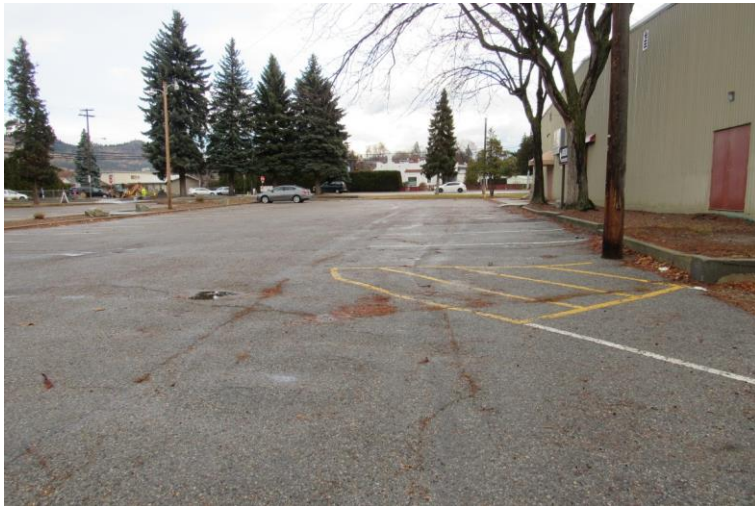
**Photo #A1: Typical condition of the asphalt paving.**

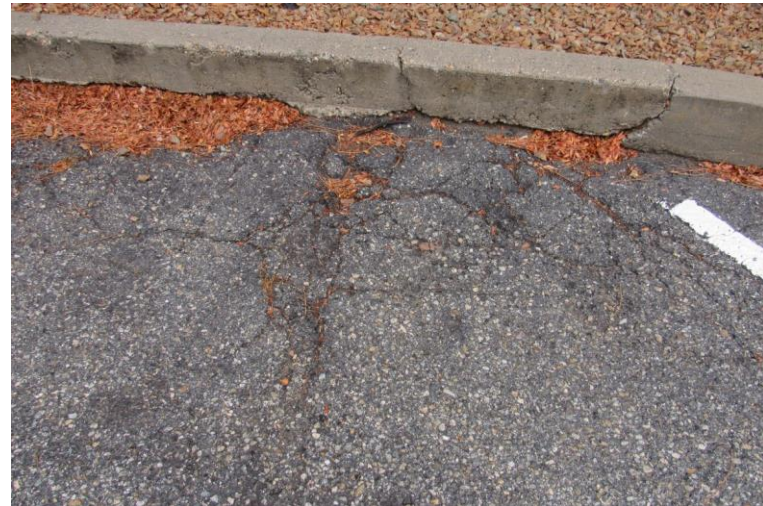
**Photo #A2: Close-up of typical asphalt and curb damage.**

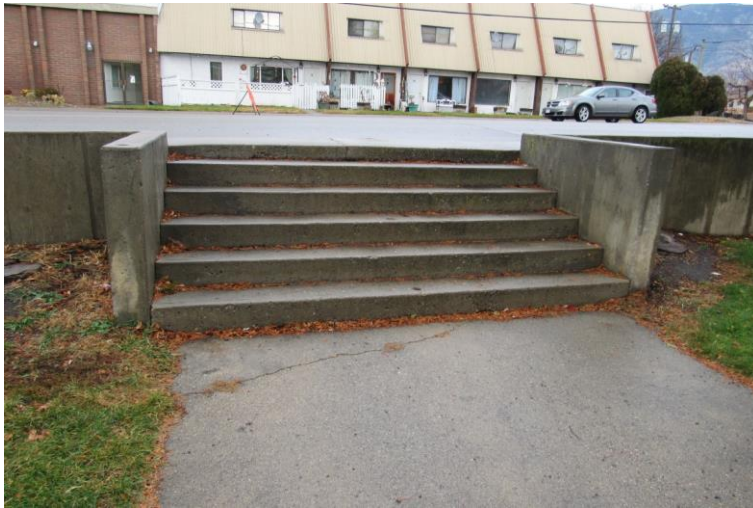
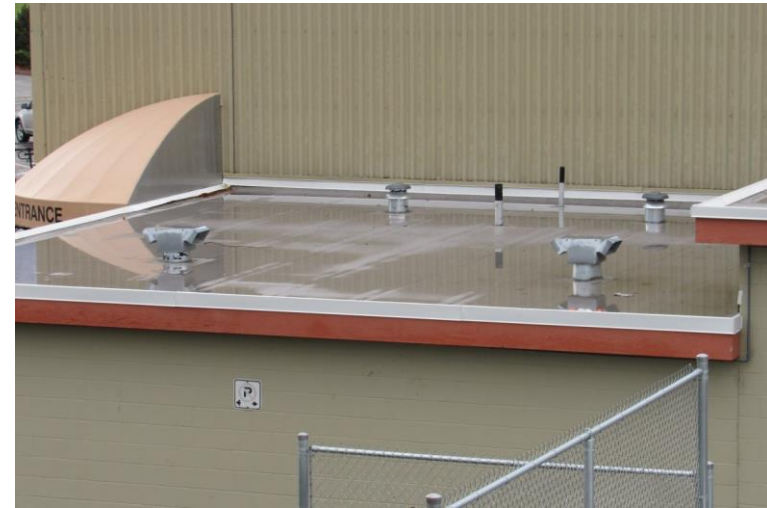
Photo #A3: The stairs and retaining wall at the main entrance.

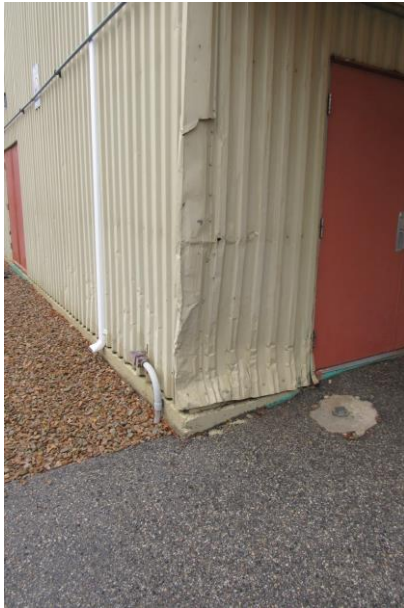
**Photo #A5: Metal siding damages at the south-east corner of the building.**

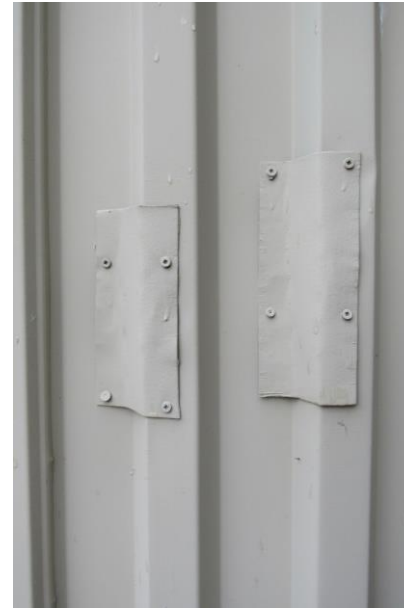
**Photo #A6: Typical metal patches observed on metal siding.**

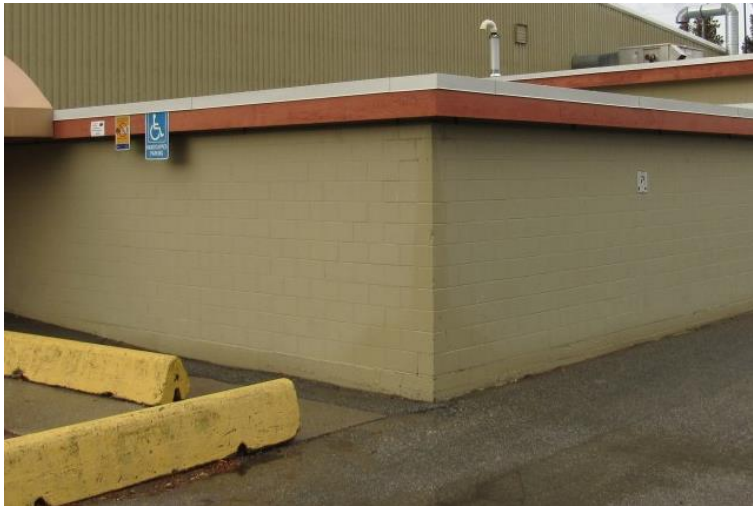
**Photo #A7: Exterior CMU wall on the south-east corner.**

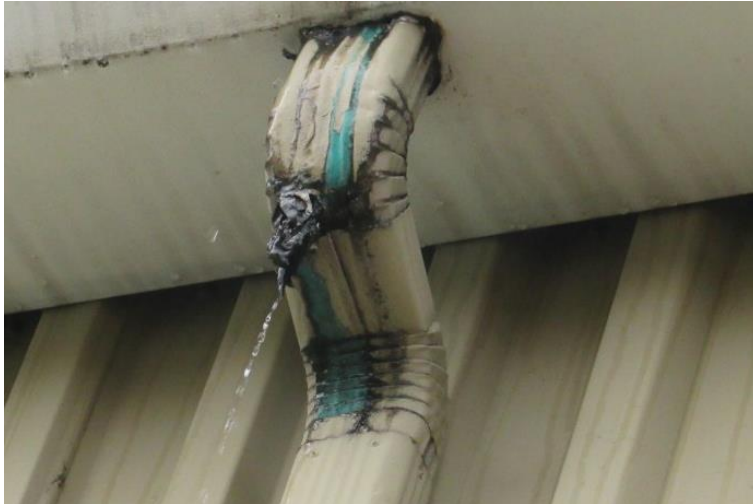
**Photo #A11: Leaking downspout.**

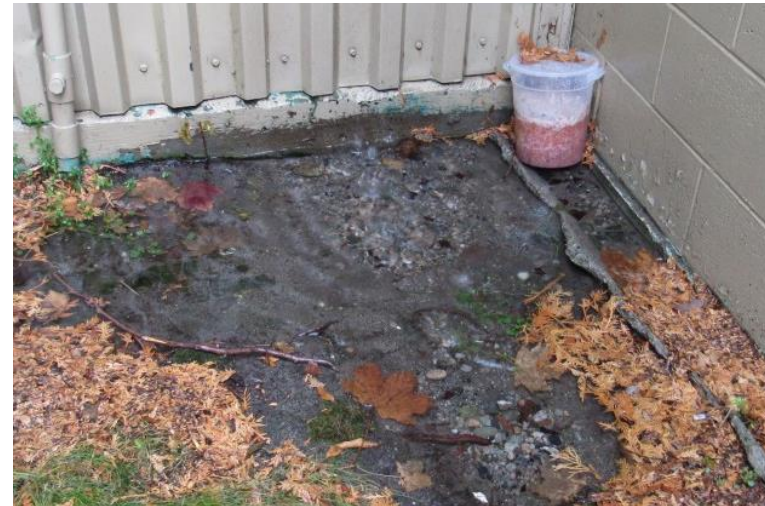
**Photo #A12: Water pooling near the main entrance caused by leaking roof gutters or downspout.**

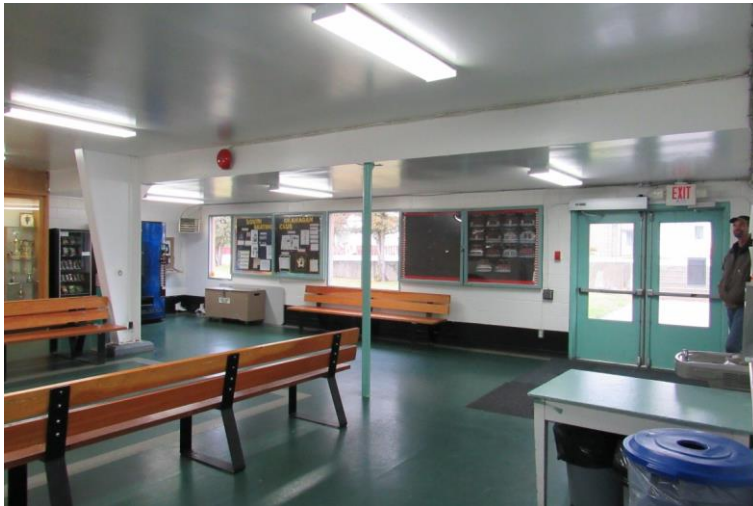
Photo #A13: .Typical finishes in the entrance area and hallways.

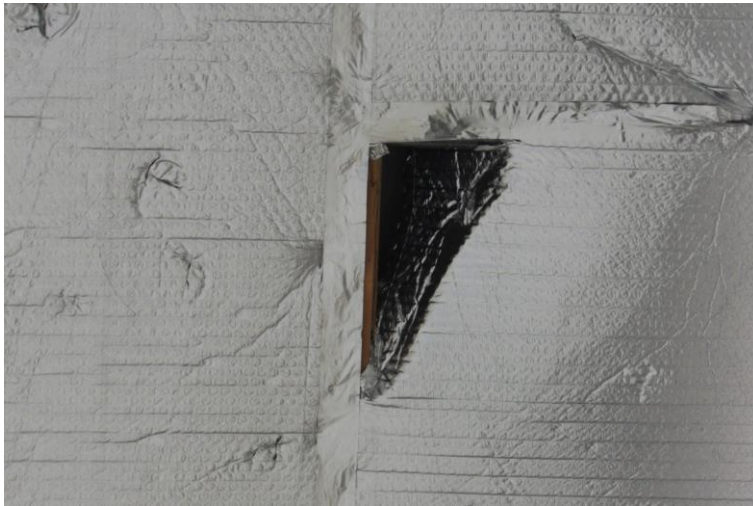
**Photo #A19: Typical minor damage on arena ceiling (batt insulation).**

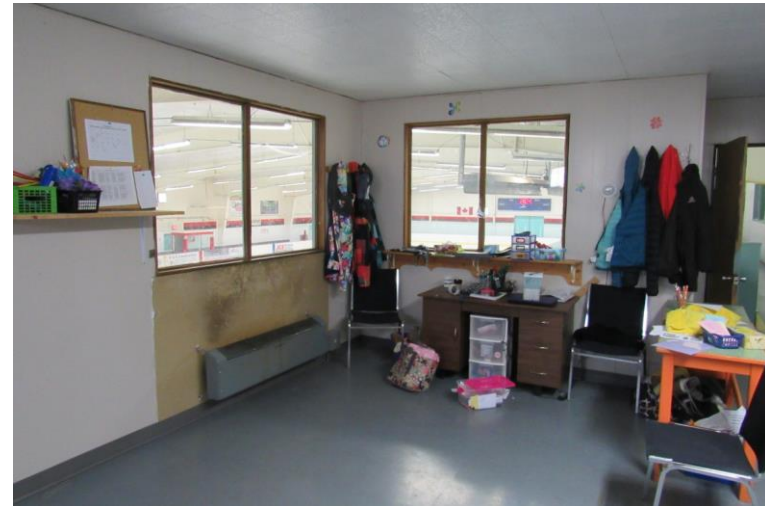
**Photo #A20: Typical finishes on the upper floor group room.**

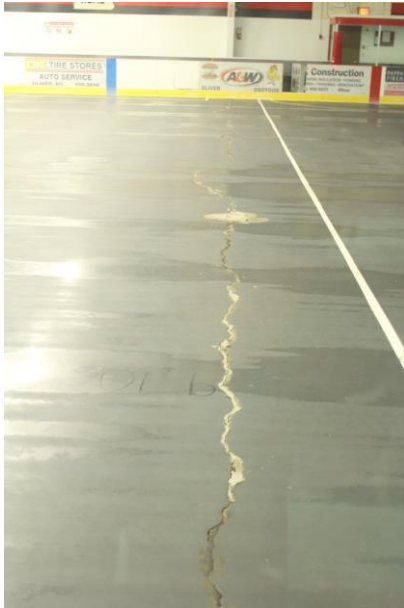
**Photo #S1: Cracked SOG ice rink floor.**

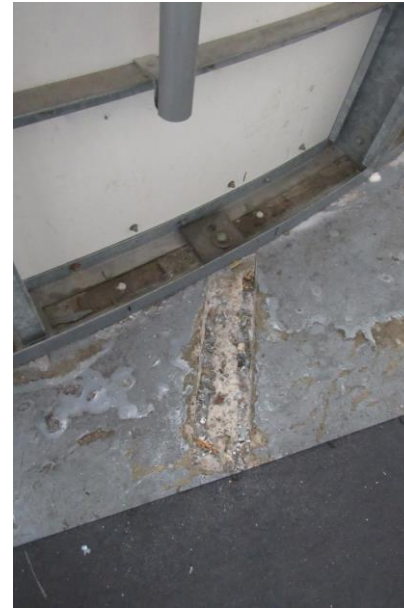
**Photo #S2: Spalling concrete just outside the rink.**

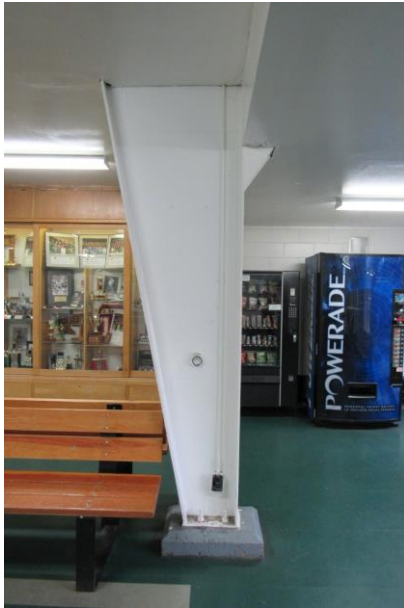
Photo #S3: Typical interior structural steel column.

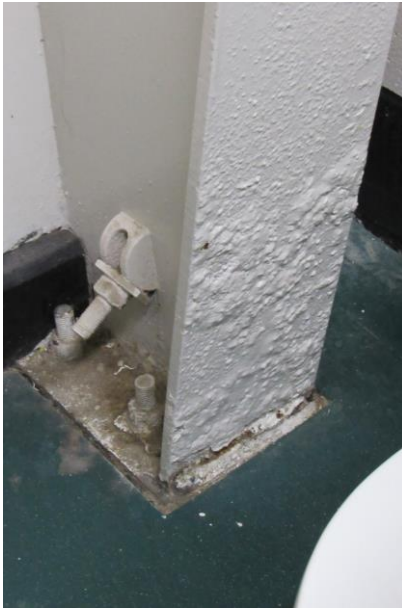
Photo #S5: Rusting observed in one of the change rooms.

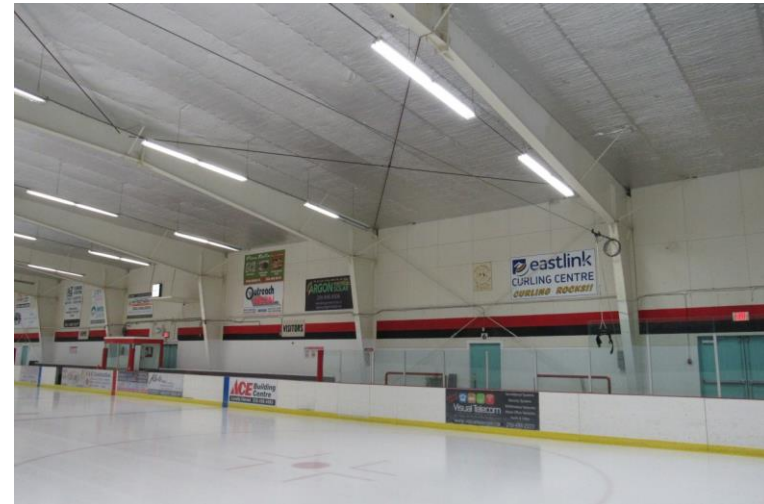
Photo #S6: Roof structure above the ice rink.

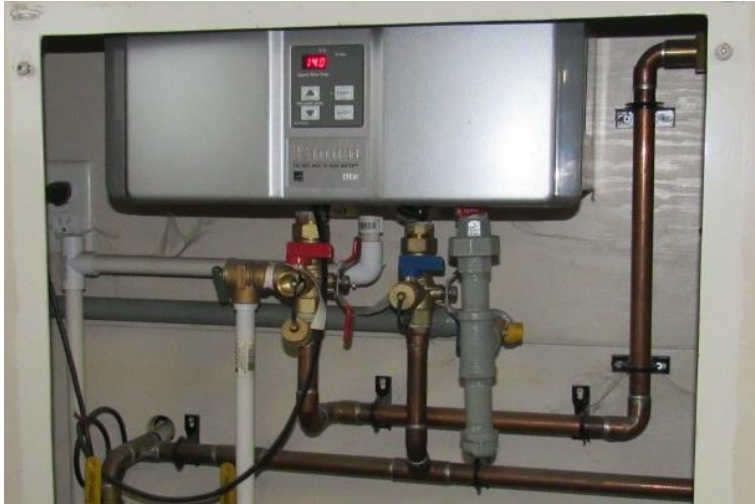
Photo #M1: Instant water heater and typical plumbing lines.

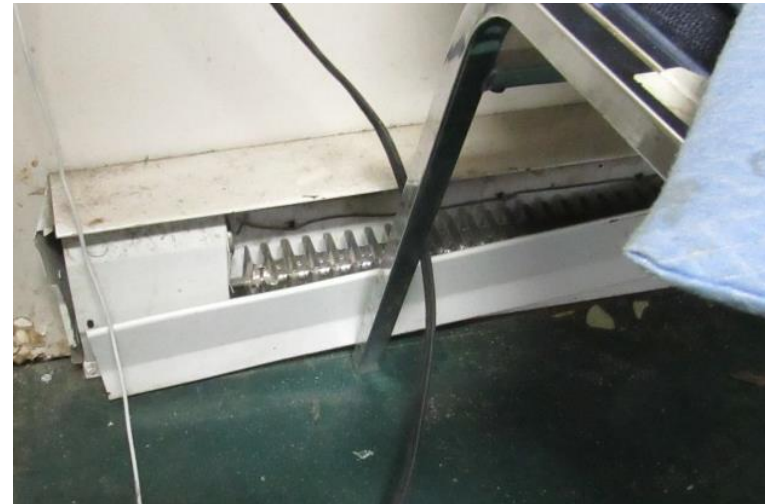
**Photo #M6: Damaged electrical baseboard heater.**

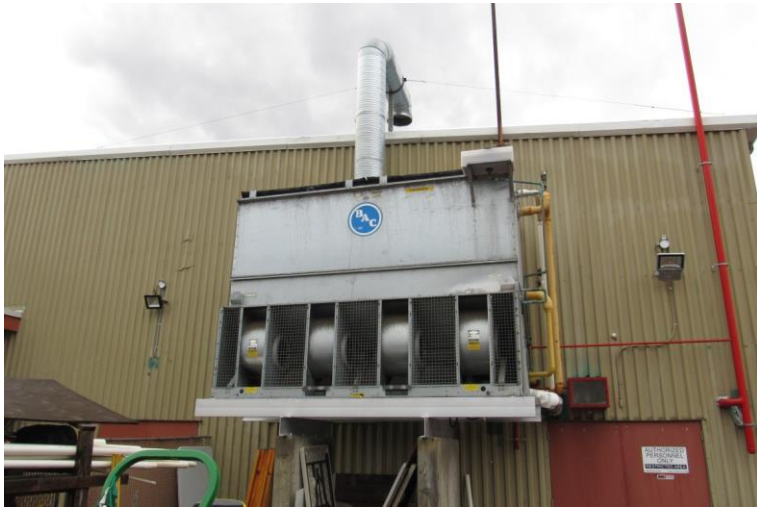
**Photo #M7: Condenser for the ice plant.**

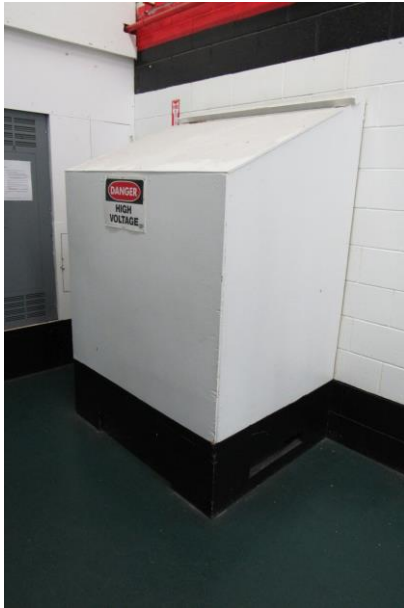
Photo #E1: Encased interior transformer.

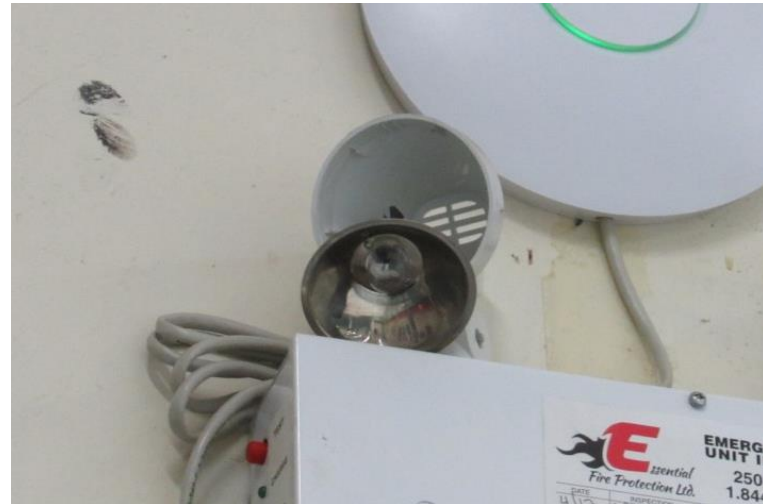
Photo #E6: Damaged emergency light.

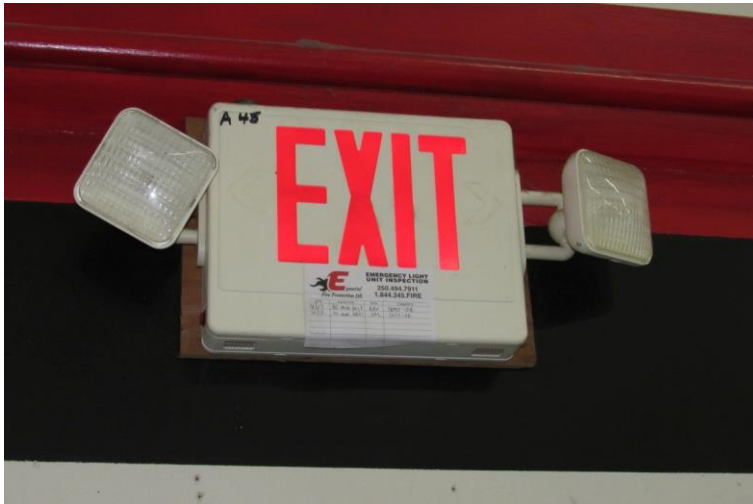
Photo #E7: Typical exit/emergency light.

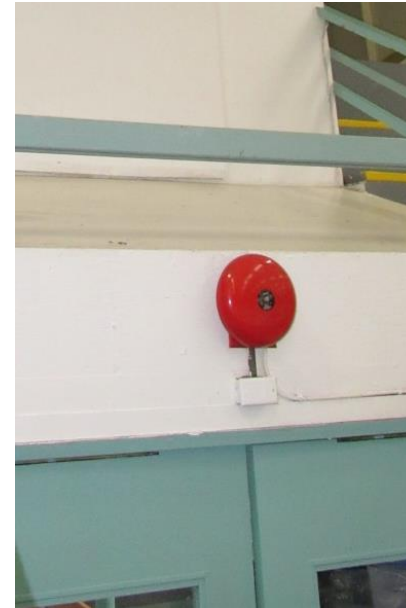
Photo #E10: Fire alarm bell.
