Sanitary Sewer System 2020 Annual Report

Town of Oliver

February 2021

Project No. 306-088-007

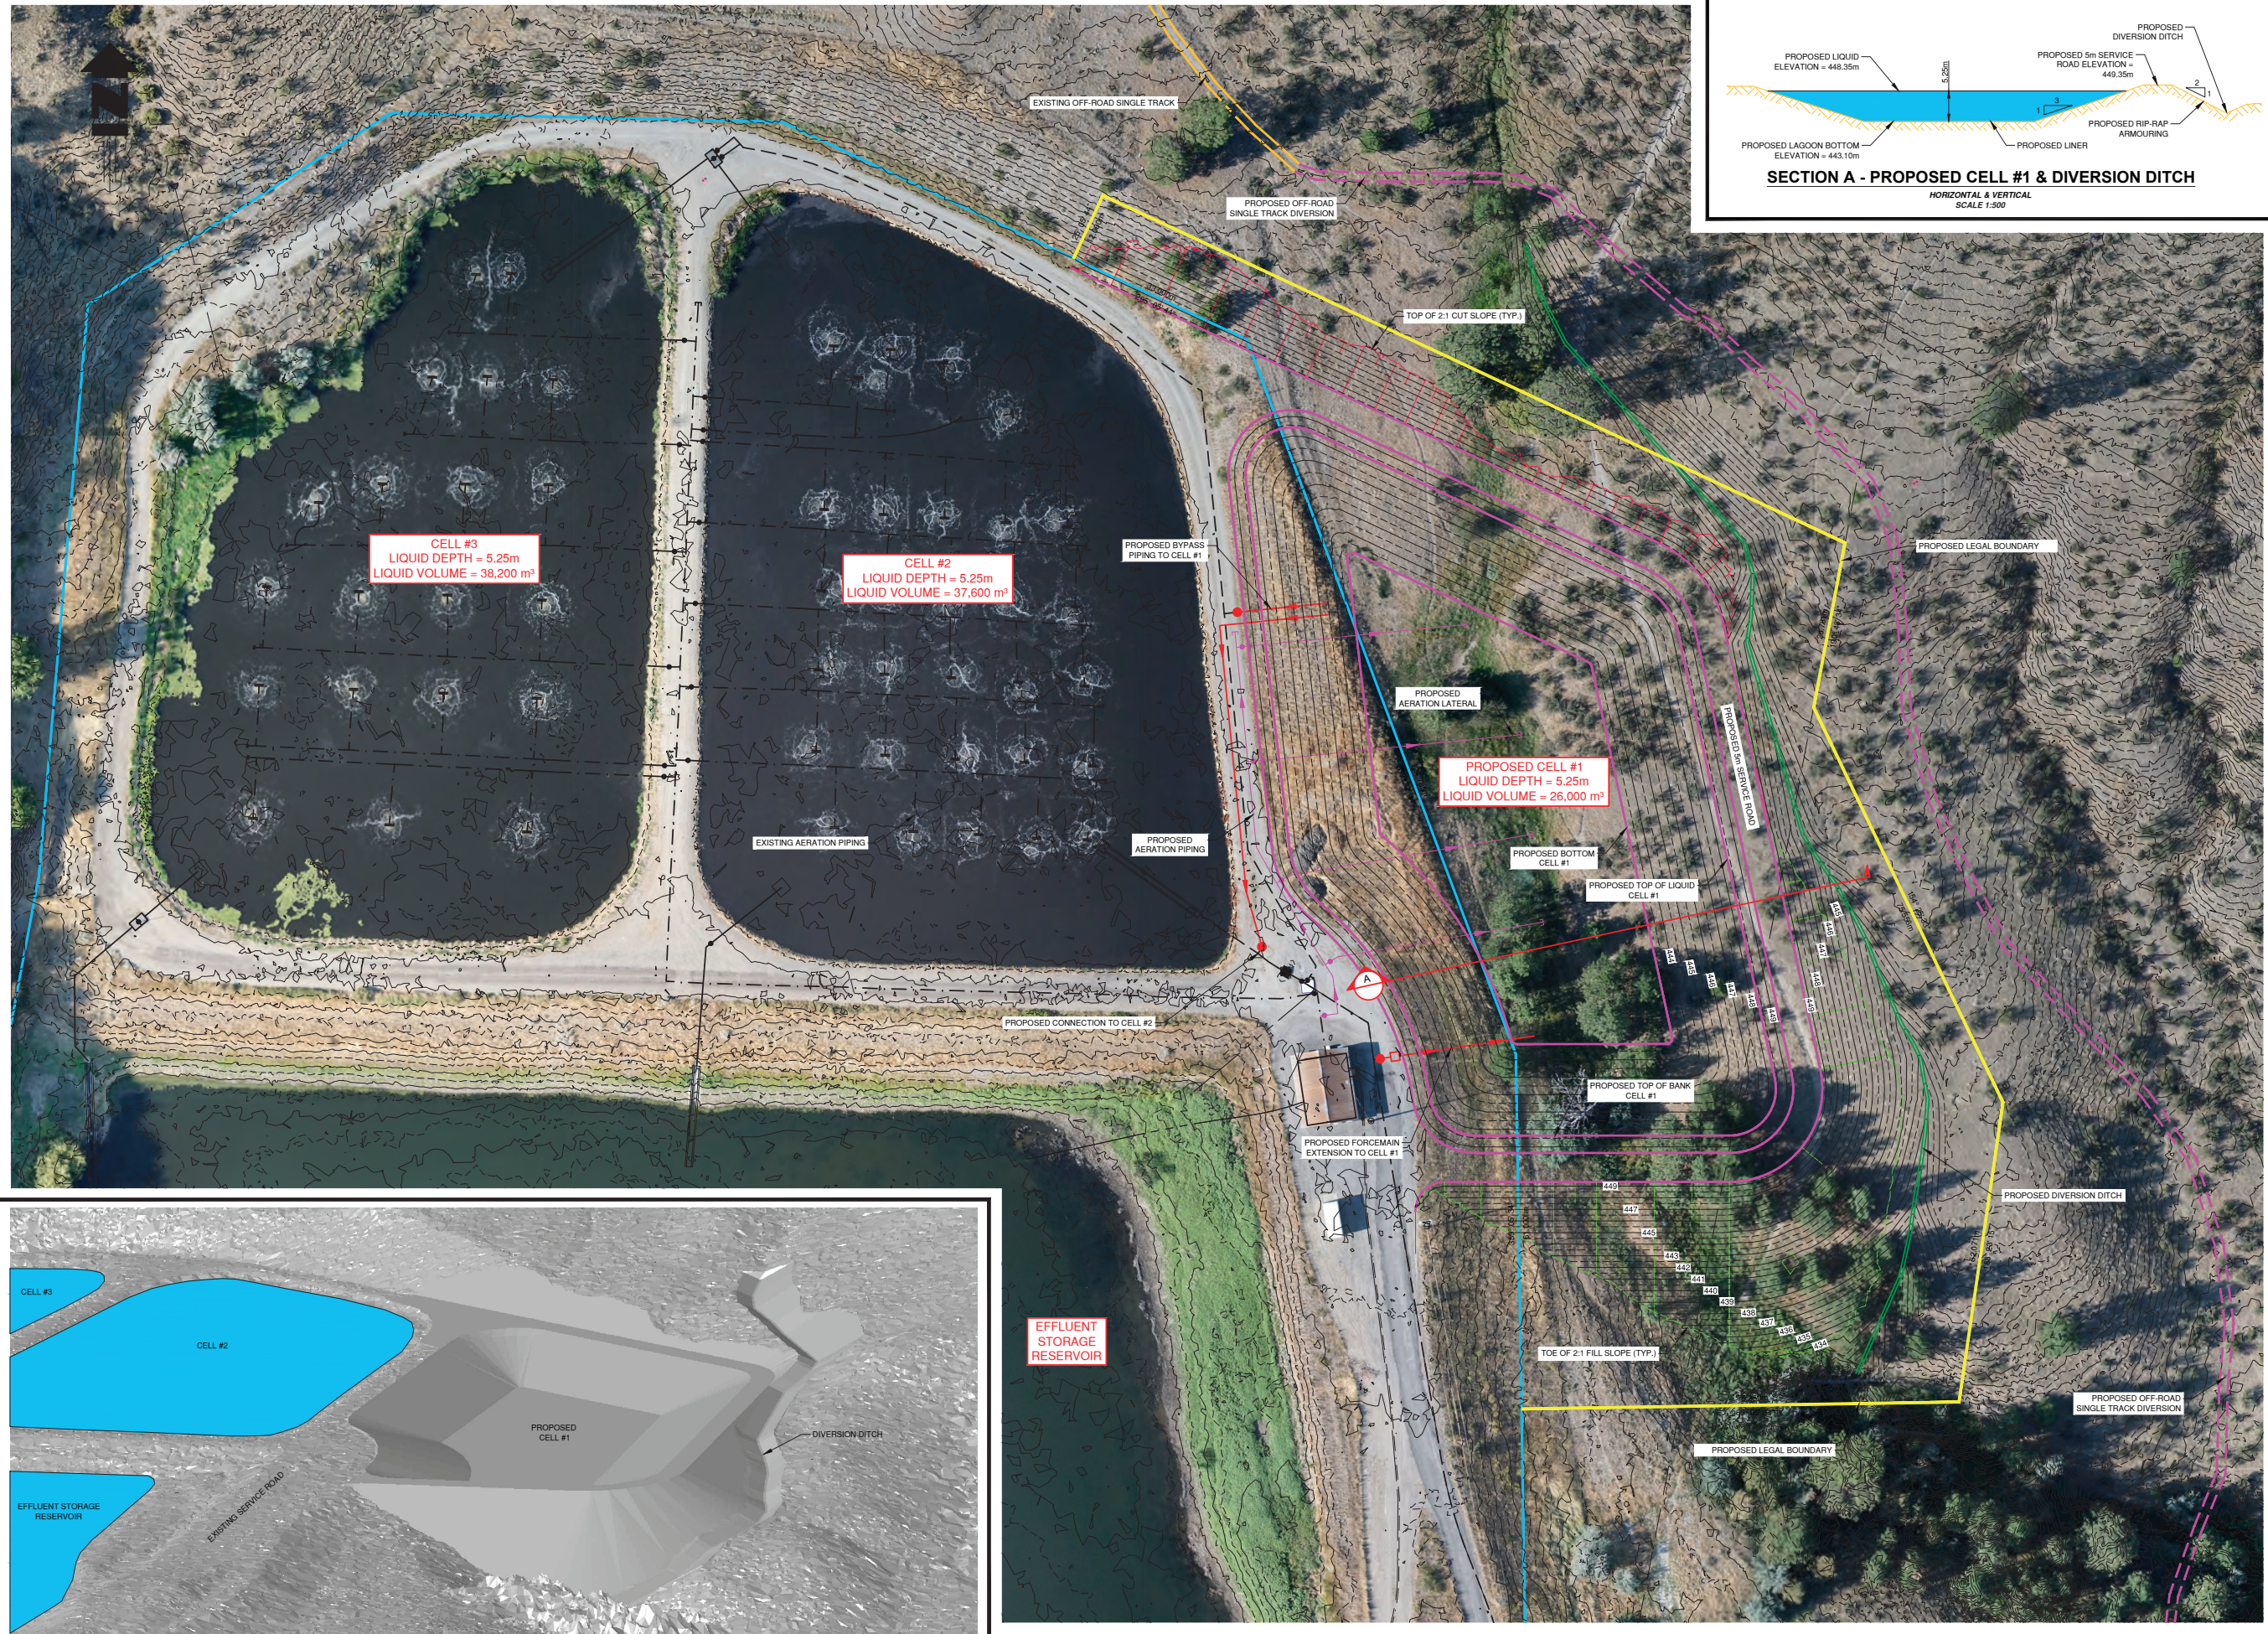
CUT/FILL QUANTITIES
PROPOSED CELL #1 EARTHWORKS

24,000 m³ (CUT)
 19,500 m³ (FILL)
 NET 4,500 m³ (CUT)

enclosures: hand calculations and drawing 306-985-Figure 1 showing the preliminary design and right-of-way requirements for the future Aerated Lagoon No. 1

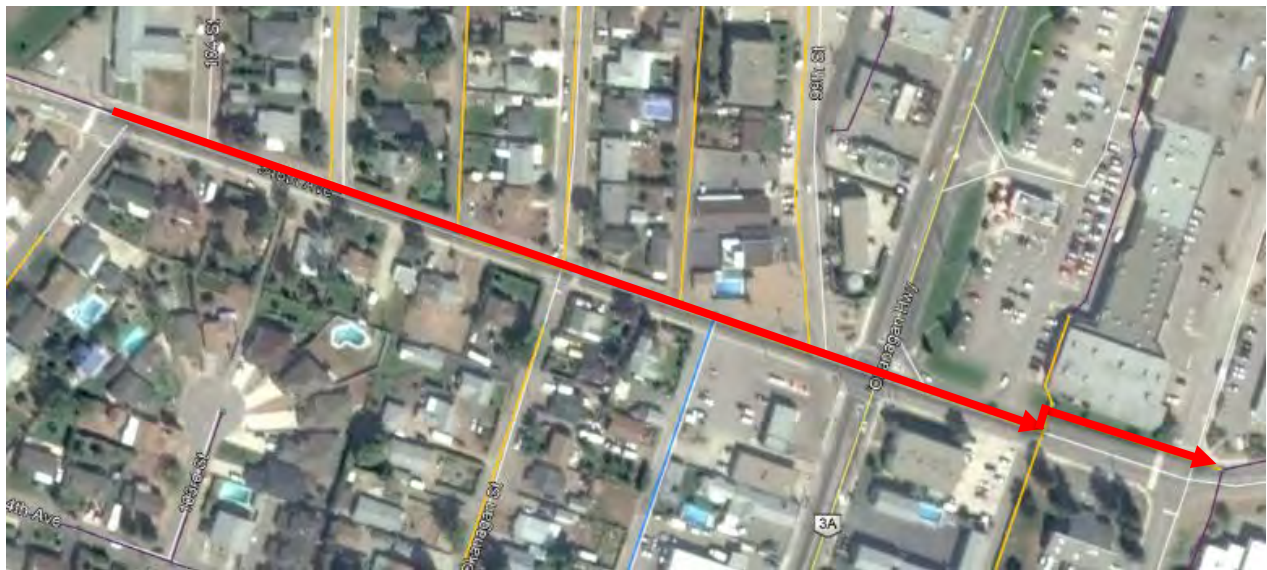
Location Map

This main is a key connection in the sanitary collection network. The existing AC and VCT pipe is beyond its anticipated useful life of 50 years, and inspections in 2016 and 2017 reported that the pipe has significant condition issues. This segment of pipe is also flagged in the hydraulic model as having capacity issues under current and future wet weather conditions.

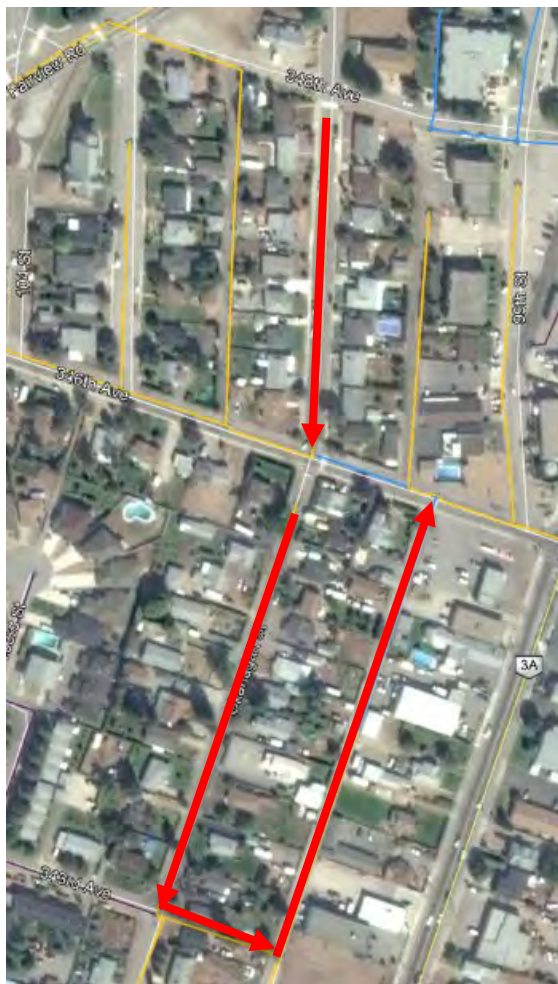
Location Map

The existing AC and VCT pipe is beyond its anticipated useful life of 50 years, and inspections in 2016 and 2017 reported that the pipe has significant condition issues.

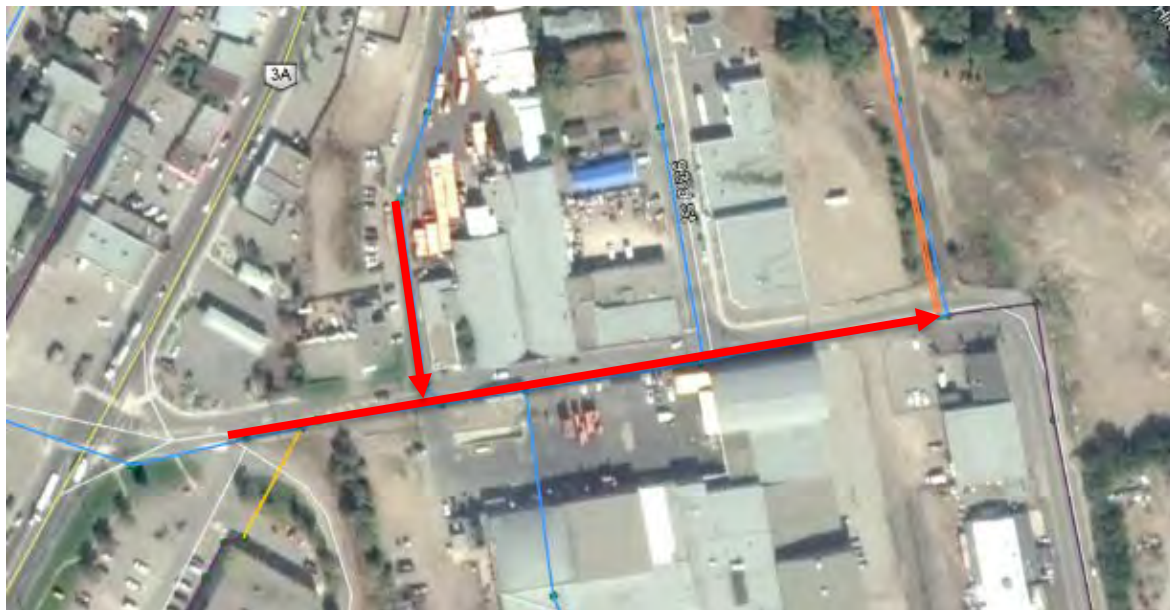
Location

This main is a key connection in the sanitary collection network. The existing VCT pipe is beyond its anticipated useful life of 50 years, and inspections in 2016 and 2017 reported that sections of the pipe have condition issues.

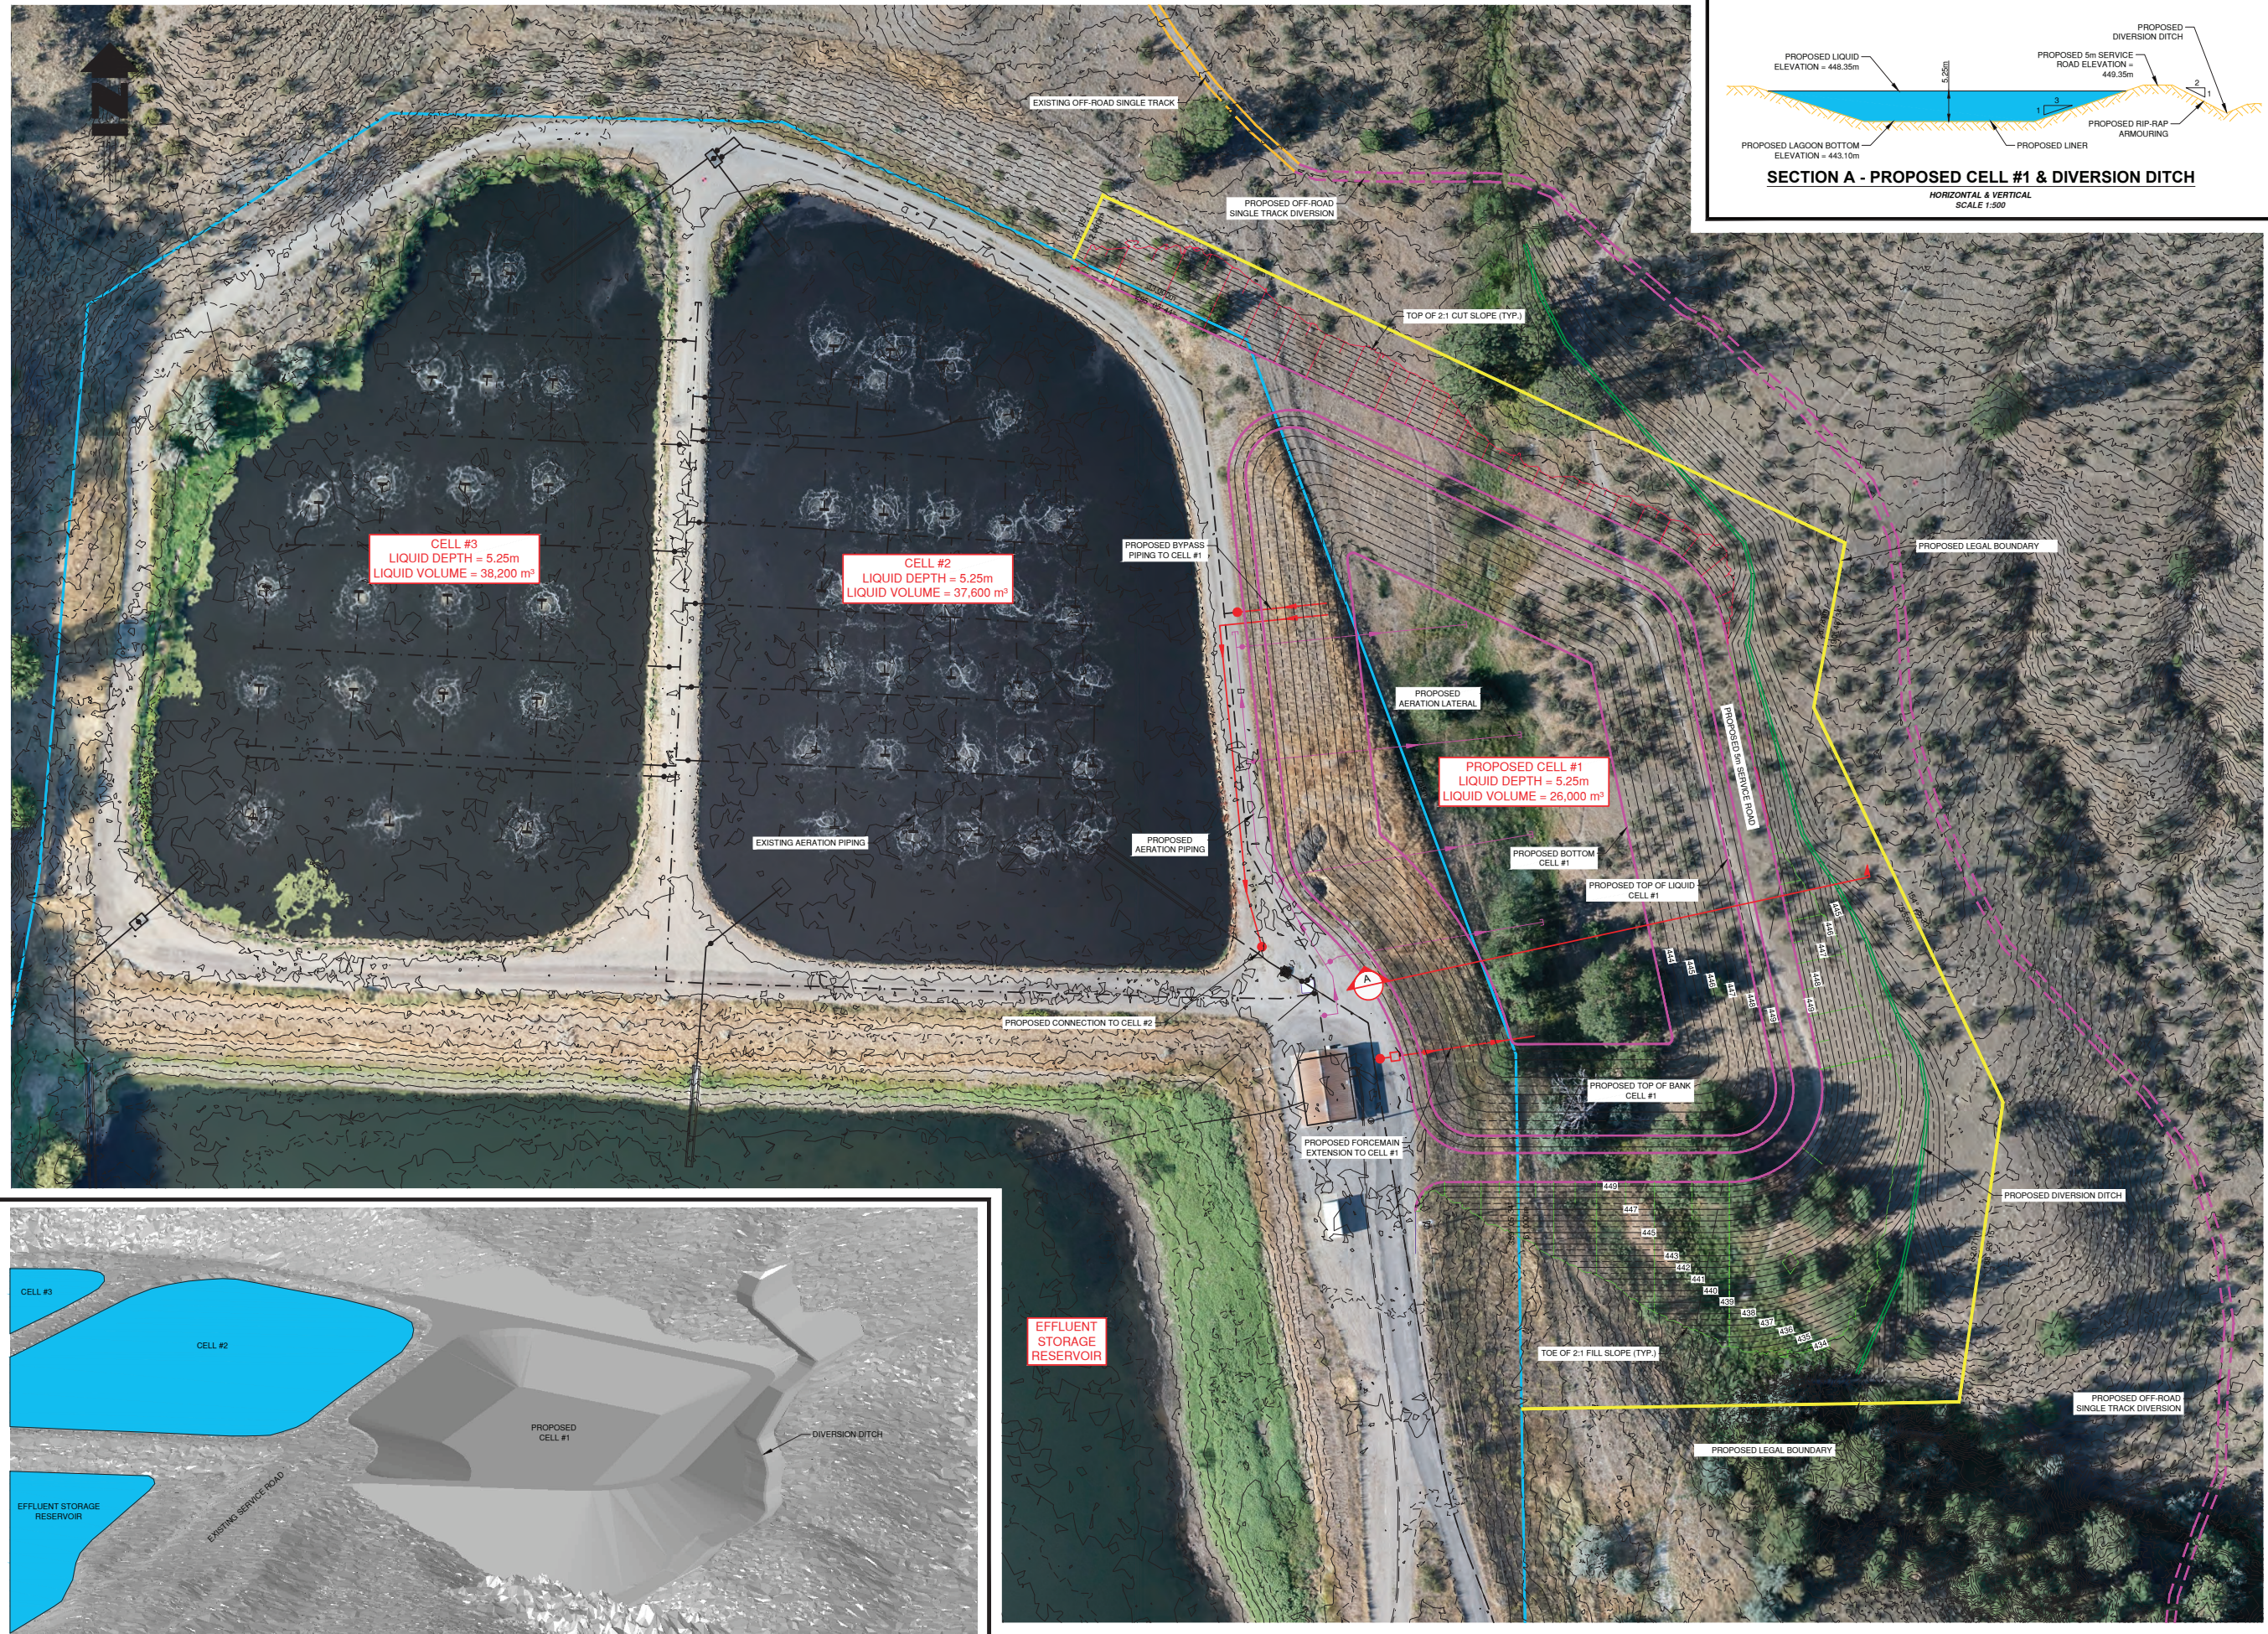
CUT/FILL QUANTITIES
 PROPOSED CELL #1 EARTHWORKS
 24,000 m³ (CUT)
 19,500 m³ (FILL)
 NET 4,500 m³ (CUT)
 NOT INCLUDING STRIPPING
 APPROXIMATE VOLUME 3,900 m³ (CUT)
 PROPOSED CELL #1 CAPACITY
 26,000 m³

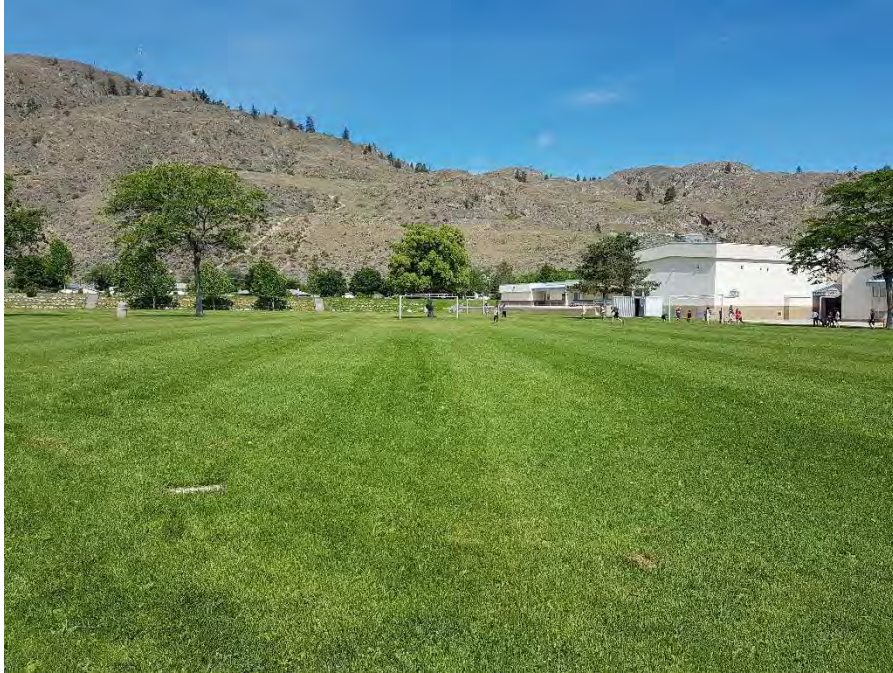
Photo 1. Sports field with turfgrass cover between elementary and high schools.

- The playing fields and park land located between Oliver Elementary School and South Okanagan High School (Figure 1 – maps and photos are at end of report). All of this parcel is currently covered with turfgrass and is irrigated with an underground sprinkler system (Photo 1). There are mature trees around the edges of the fields.
- Oliver Cemetery (Figure 2). The cemetery grounds are primarily vegetated with turfgrass (Photos 3 and 4) and are irrigated with underground sprinklers. Trees (mostly cedar) are planted around the property boundary, and there are some deciduous tree among the monuments.
- Oliver Community Park located immediately east of the Okanagan River on Fairview Road (Figure 3). The park includes three baseball/softball fields, a lawn bowling green, and areas for walking and sitting. The ground cover is turfgrass and there are a number of mature trees in the

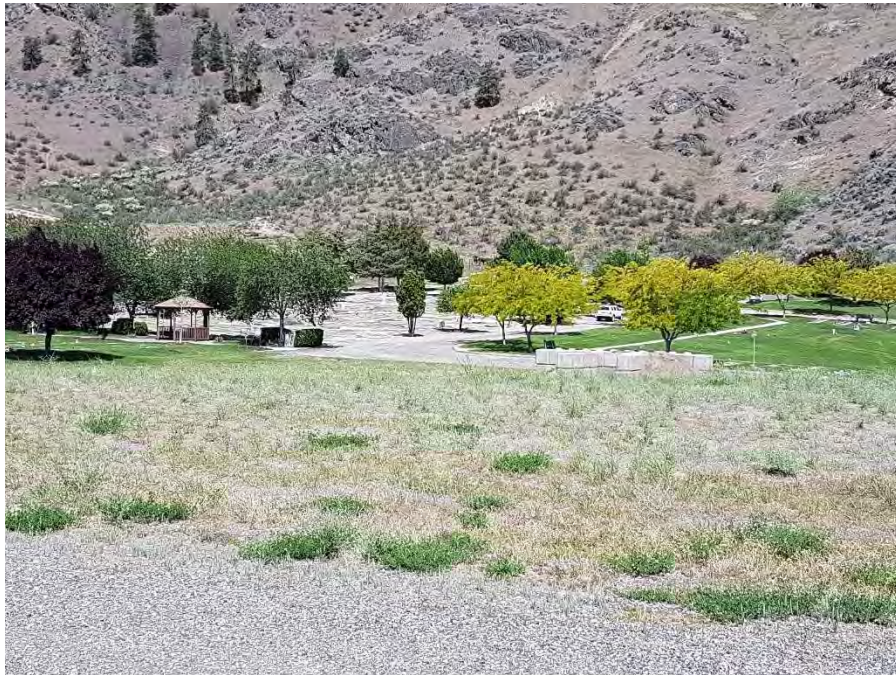
Photo 4: Cemetery overview showing unirrigated and irrigated (background) areas.

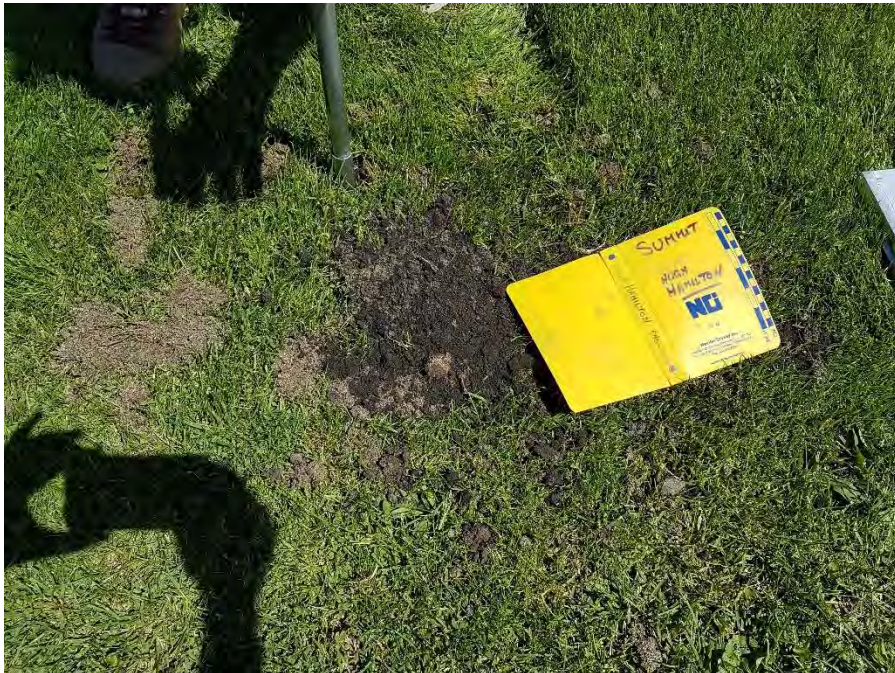
Photo 6: Example of silty soil in north part of Oliver Community Park

Soil information for the subject property was obtained from the BC Soil Information Finder Tool (SIFT). Figures 1 to 4 show the spatial distribution of soil types on the planned irrigation sites, and the soil properties are summarized in Table 1. Soils at the school and airport sites are mapped by BC as 100% Rutland soils, which are classified as Orthic Dark Brown Chernozems, developed on glacio-fluvial deposits. They typically are gravelly with a sandy or sandy loam surface texture (Photo 2). Soils at the cemetery are Ponderosa soils developed on alluvial fan deposits with a fluvial veneer. They are classified as Rego Dark Brown Chernozems and are also gravelly within sandy loam. The soils in the park have been developed on fluvial and floodplain deposits. About 90% of the irrigated area is classified as Kinney soils and are Gleyed Regosols (signifying that they are relatively young and that the soil profile is routinely saturated for an extended period). The northwest part of the park as mapped as Cawston soils, a Rego Gleysol (indicating somewhat greater soil profile development but also routinely saturated). The Kinney soils have a sandy loam or loam texture with some silt lenses, while the Cawston soil is a silt loam (Photo 6).

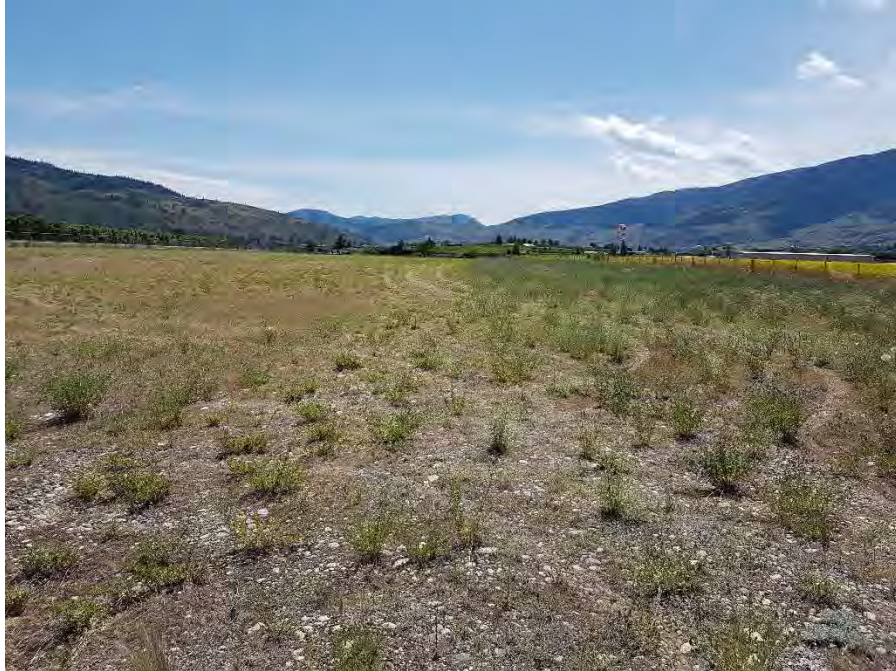
Photo 7: Proposed new irrigation area at airport. Note exposed sub-soil and relatively sparse vegetative cover [Land on right side of photo may receive some irrigation water from fields near runway (yellow flowers)].

- Oliver Municipal Airport (Map 4). The new irrigation area is the strip of industrial-zoned land on the east side of the runway (Photo 7). The fields surrounding the runway to the west are already authorized for reclaimed water irrigation. The new irrigation area is mostly unoccupied although some parts are used for storage and there is one building. It appears that the topsoil was stripped from parts of the site and transported off-site. Vegetation cover is limited (about 25-50% on average) and includes alfalfa, agronomic and native grasses, and invasive species (see Section 4). It is not currently irrigated.

The soil properties observed in the field were consistent with the existing BC mapping, indicating that the published soil information (SIFT) can be relied upon for irrigation planning. The key exception is the land on the airport site where the topsoil (likely the Ap horizon¹ or the combined A and B horizons appear to have been stripped off in places, exposing the underlying gravelly BC or C horizon that is characteristic of the Rutland soil (Wittneben 1986). This was confirmed by digging a soil pit on the west side of the fence in the alfalfa field that surrounds the runway, where a dark brown Ap horizon (~0.3 m thick) was present (Photo 8). At the airport site there is considerable gravel exposed on the surface among pockets of thin sandy soil. The vegetation cover is sparse (Photos 7, 9 and 10).

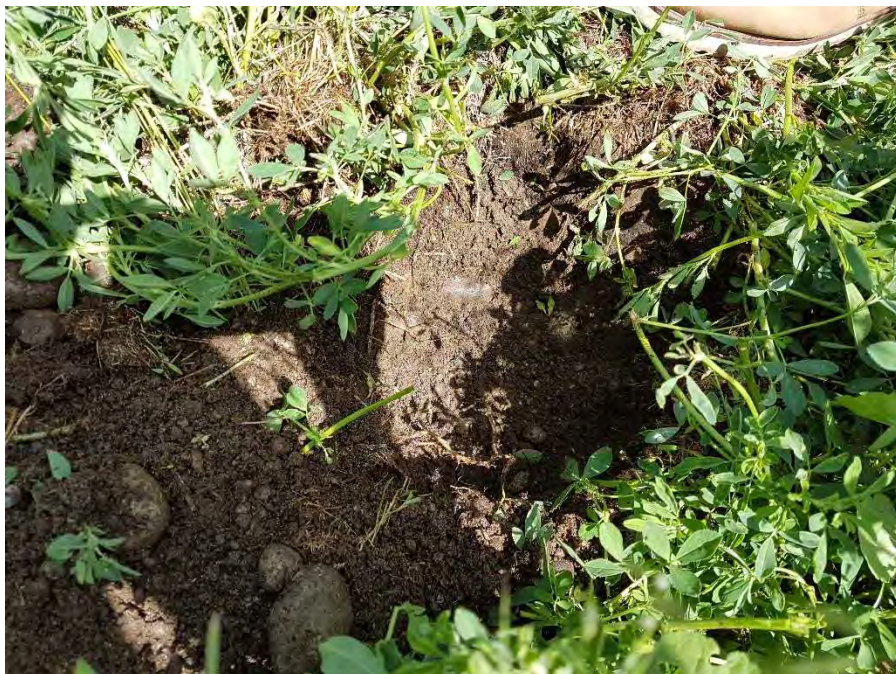
Photo 8: Surface soil in irrigated fields. Note intact dark upper horizon and presence of gravel throughout.

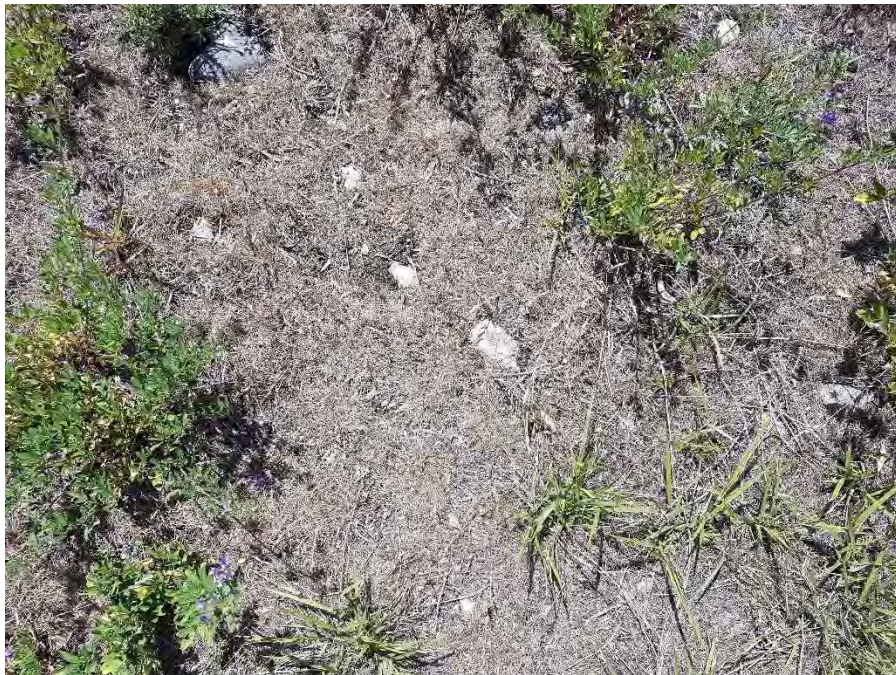
Photo 10: Ground surface at new airport irrigation area where topsoil may have been partially removed. Note how alfalfa plants are green as their roots obtain moisture from deep within soil.
