Sanitary Sewer System 2021 Annual Report

Town of Oliver

February 2022

Project No. 306-088-009

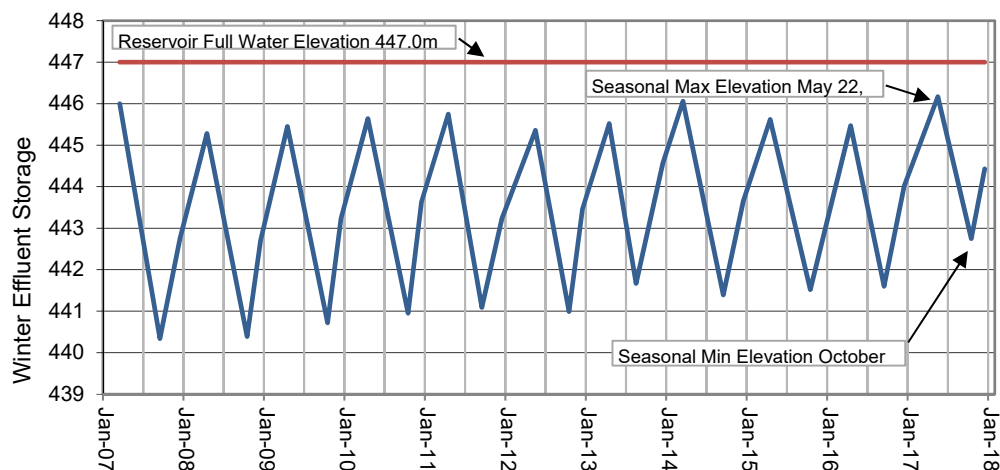
FIGURE 4-1: RESERVOIR WINTER EFFLUENT STORAGE ELEVATIONS (2005-2017)

The service capacity of the storage reservoir is dependent on climatic conditions both in the preceding irrigation season and the spring following the storage period. Construction of the infiltration basin in 2014 now assists the Town in addressing climatic variability. Winter storage requirements are derived from volume and flow data. A summary of winter effluent storage volumes from 2007-2017 is provided in Figure 4-1.

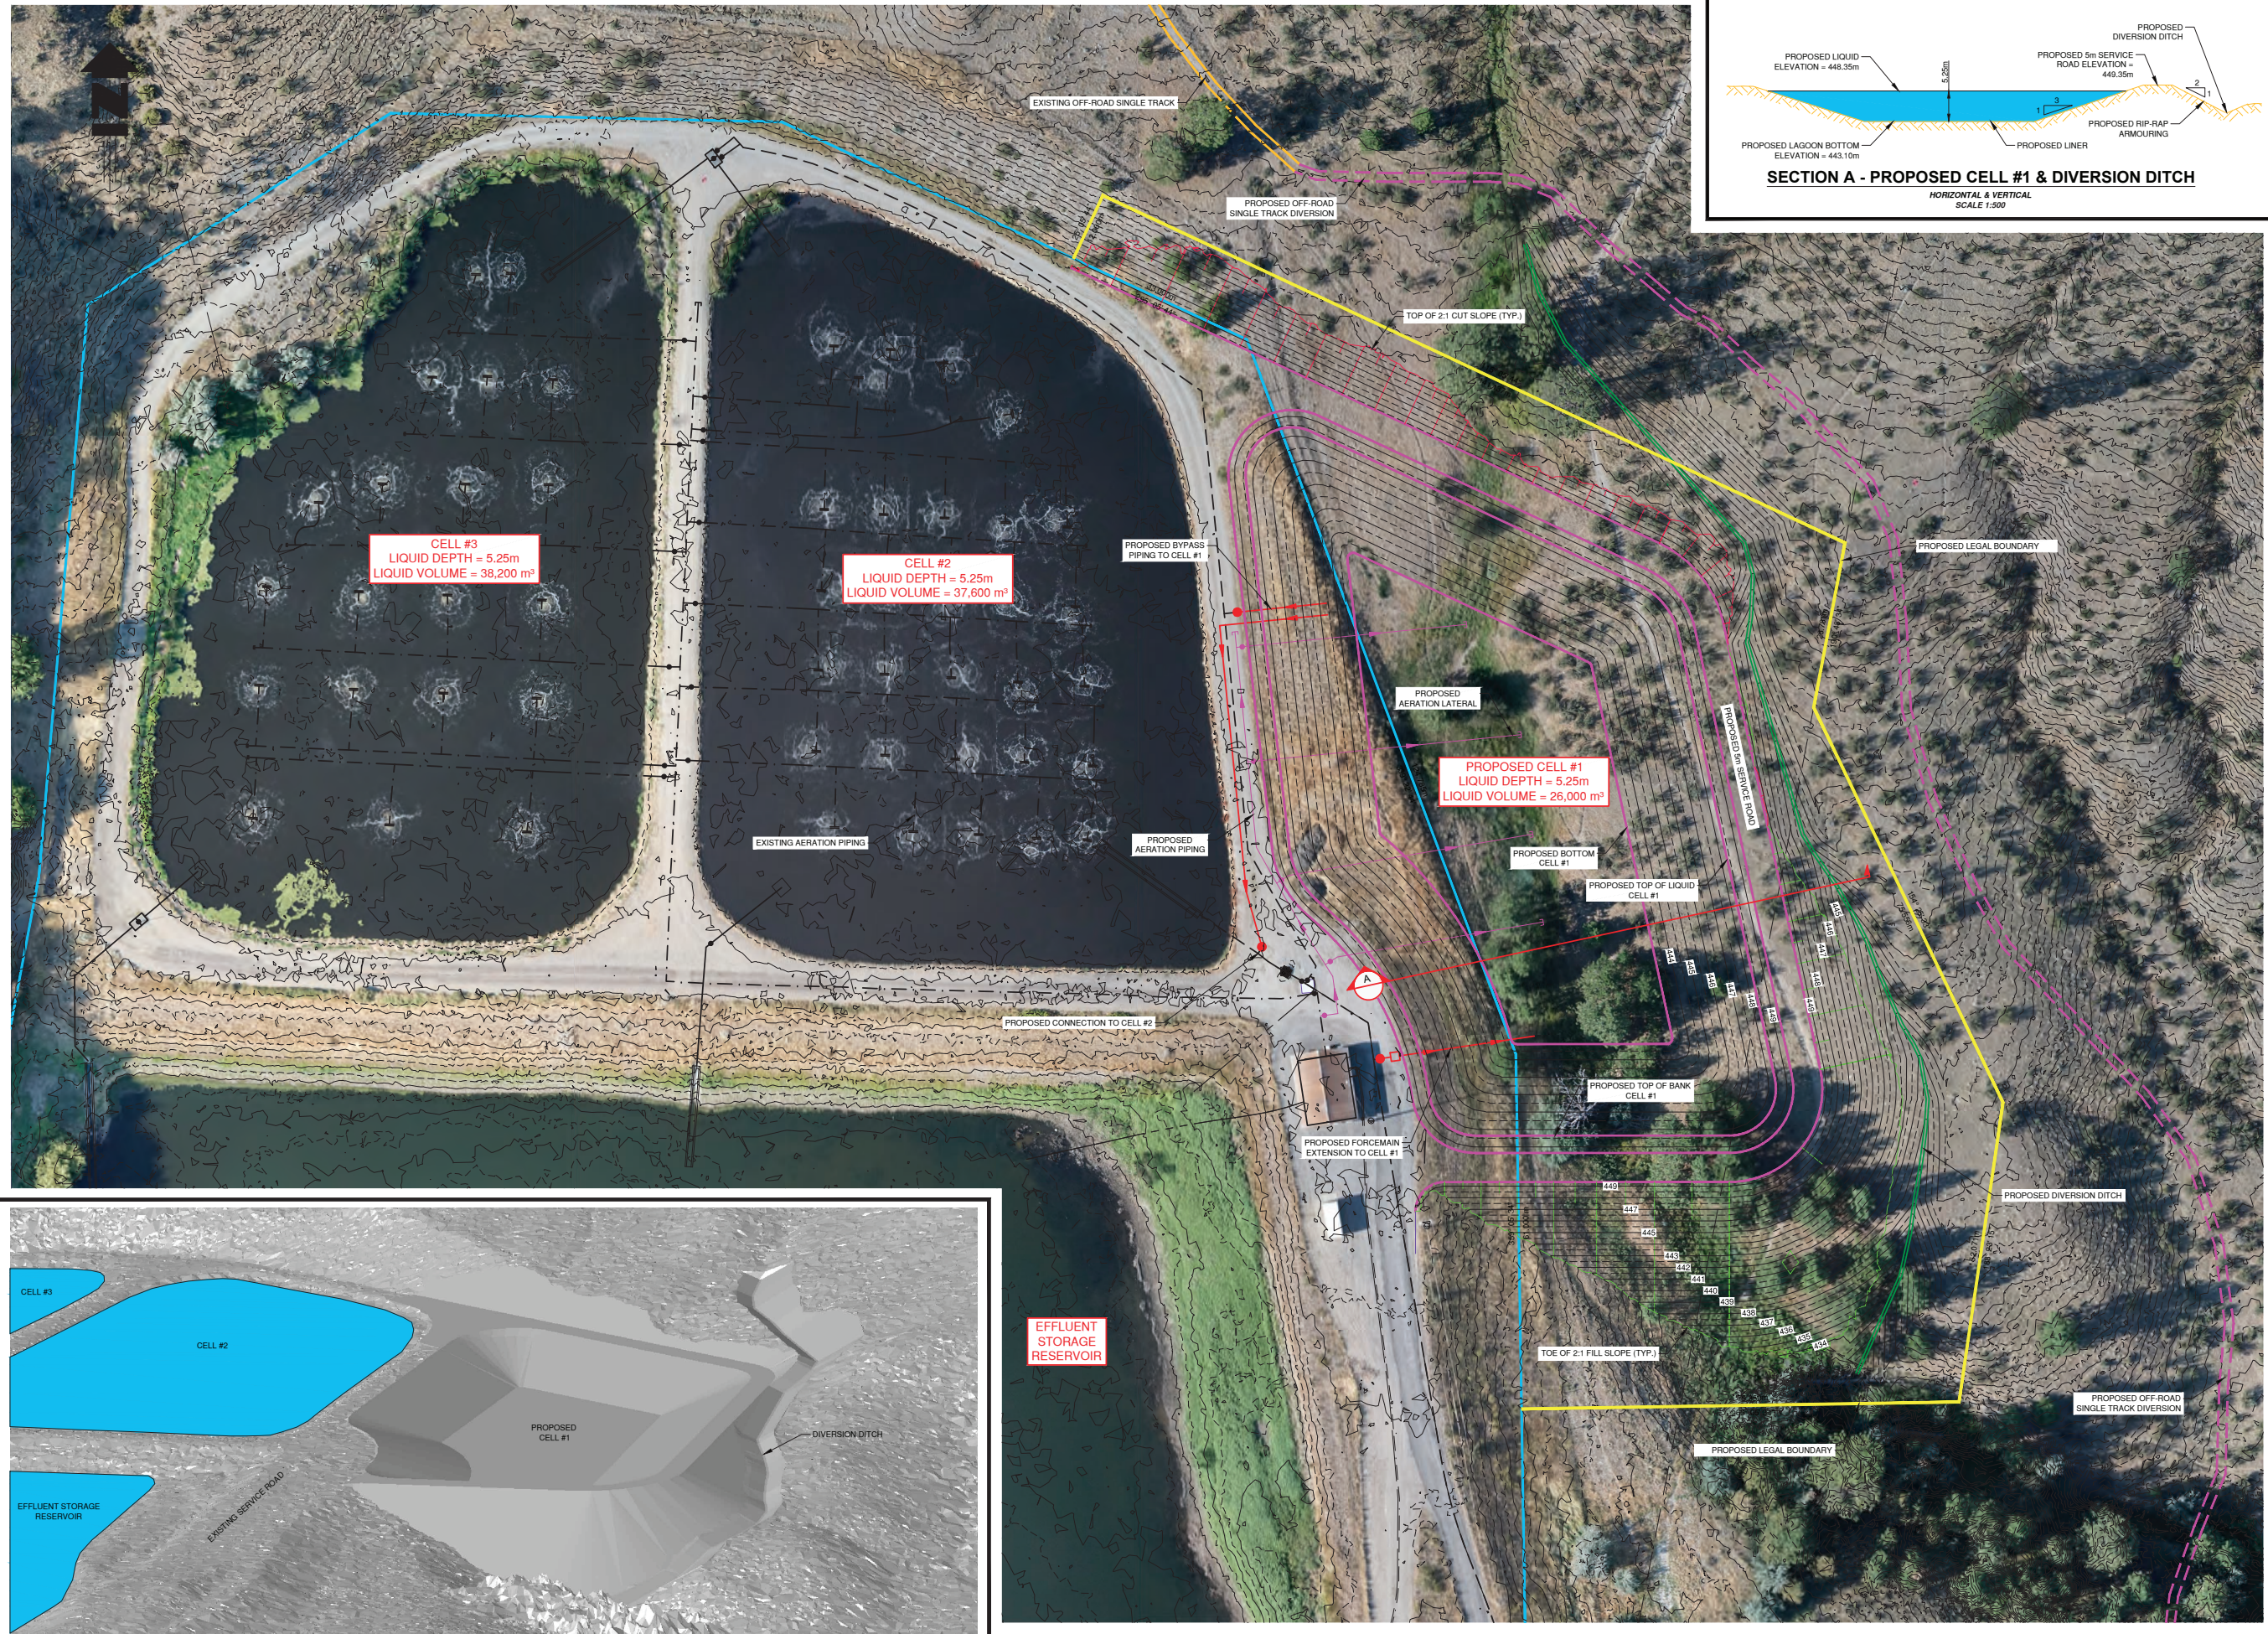
enclosures: hand calculations and drawing 306-985-Figure 1 showing the preliminary design and right-of-way requirements for the future Aerated Lagoon No. 1

CUT/FILL QUANTITIES
PROPOSED CELL #1 EARTHWORKS
 24,000 m³ (CUT)
 19,500 m³ (FILL)
 NET 4,500 m³ (CUT)
 NOT INCLUDING STRIPPING
 APPROXIMATE VOLUME 3,900 m³ (CUT)
 PROPOSED CELL #1 CAPACITY
 26,000 m³

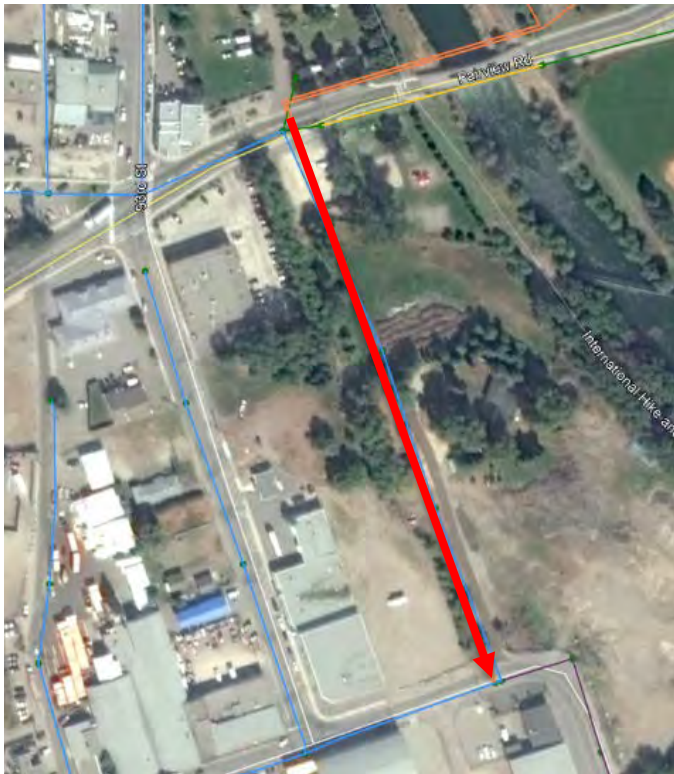
Location Map

This main is a very critical connection in the sanitary collection network, and services a corridor of future development. The 300 mm VCT pipe has surpassed its anticipated useful life.

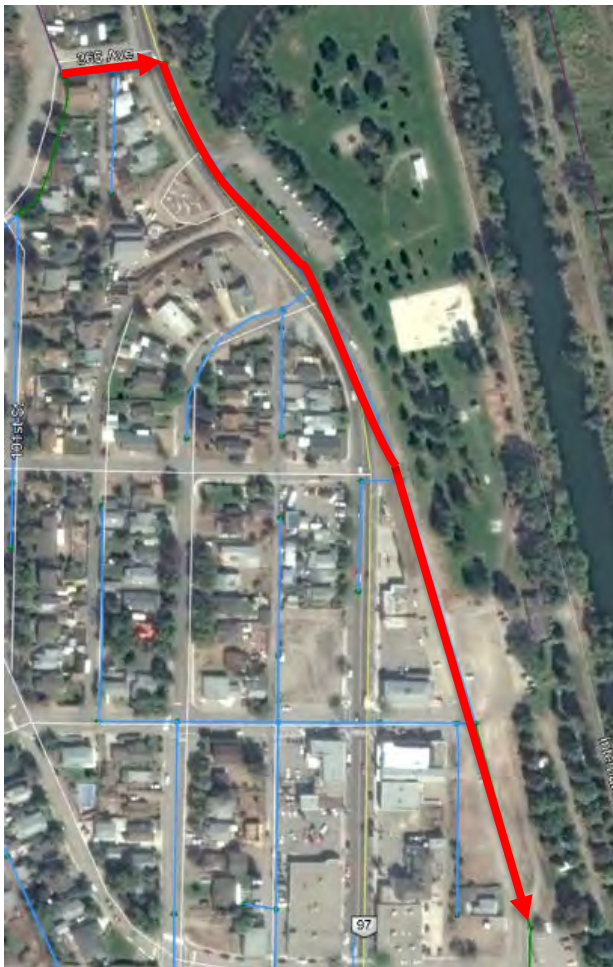
Location Map

This main is a key connection in the sanitary collection network, and services a corridor of future development. The existing VCT pipe has surpassed its anticipated useful life.

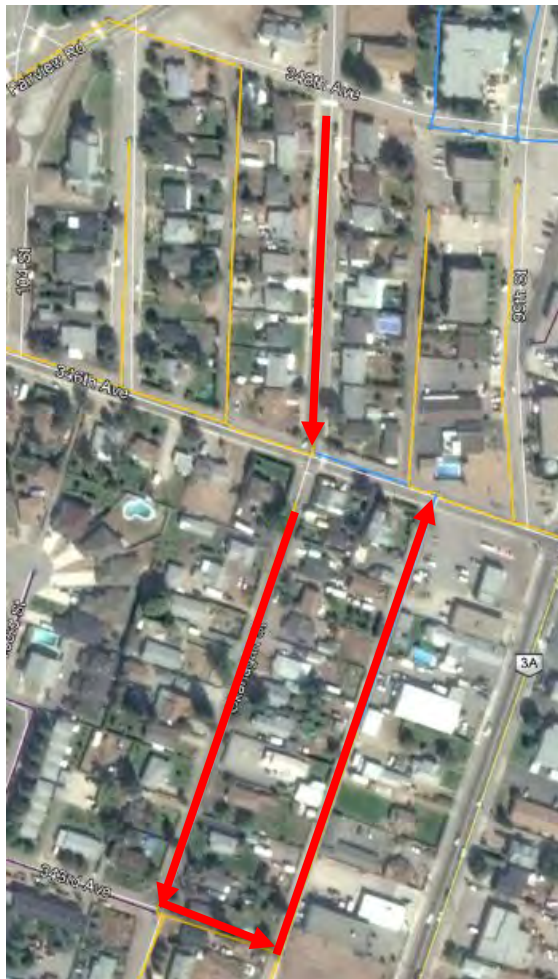
Location Map

The existing AC and VCT pipe is beyond its anticipated useful life of 50 years, and inspections in 2016 and 2017 reported that the pipe has significant condition issues.

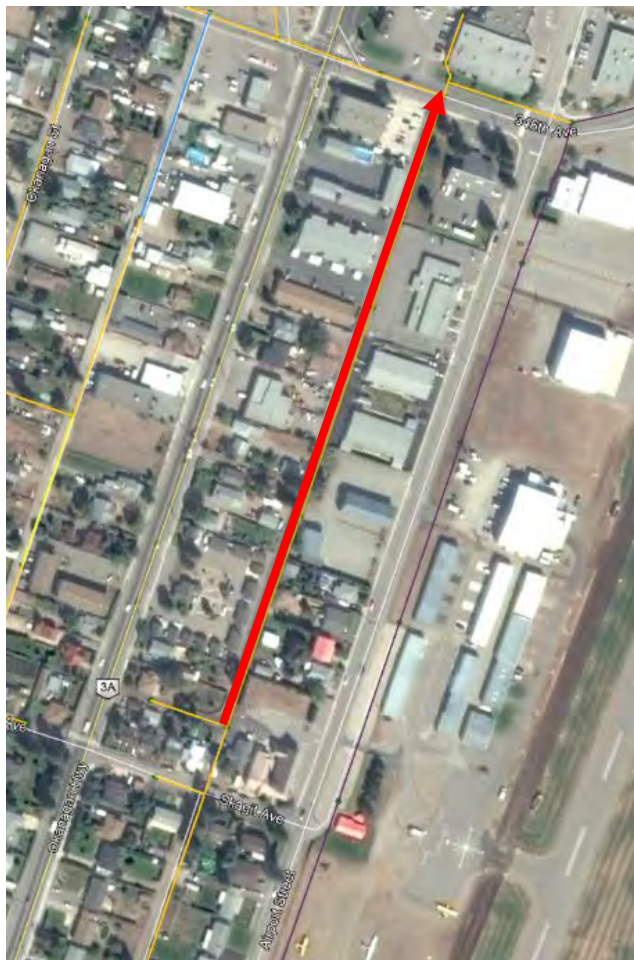
Location

The existing AC pipe is beyond its anticipated useful life of 50 years, and inspections in 2016 and 2017 reported that the pipe has significant condition issues.

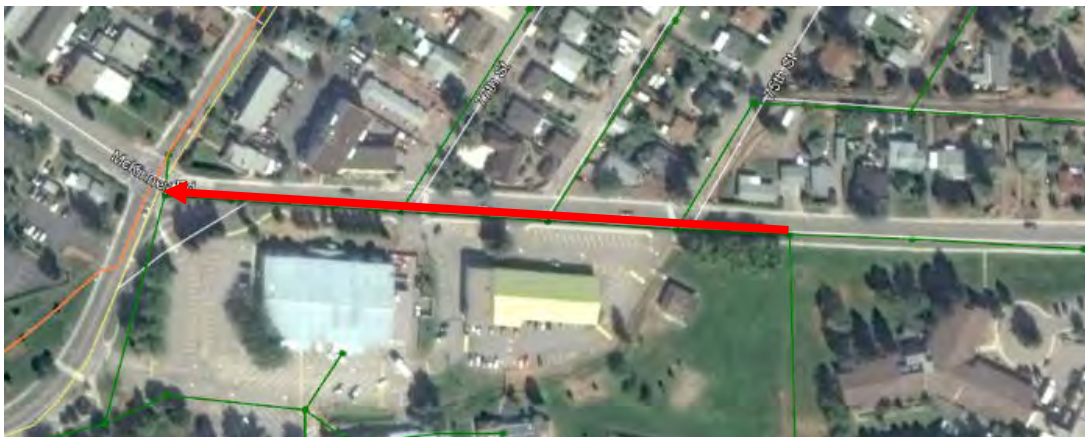
Location Map

The existing 200 mm AC pipe is beyond its anticipated useful life of 50 years. Inspections in 2016 and 2017 reported that the pipe is in acceptable condition given its age. Rehabilitation is intended to extend the useful life of these assets with decreased cost.

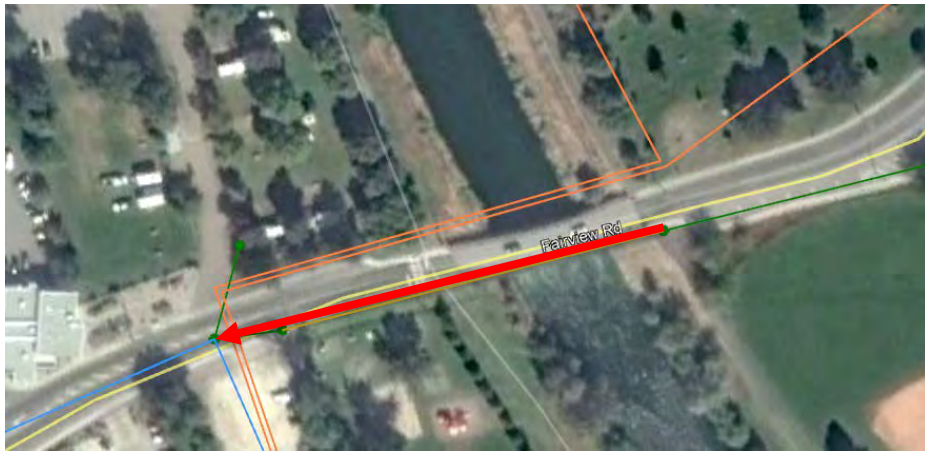
Location Map

This main is a very critical connection in the sanitary collection network. The existing 200 mm AC pipe is beyond its anticipated useful life of 50 years and is a high risk asset to the collection network.

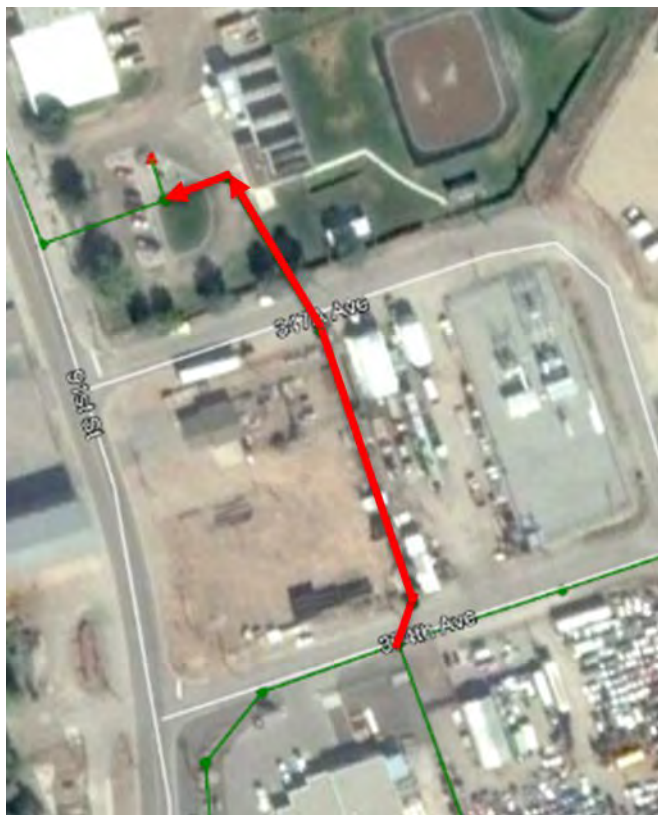
Location Map

This main is a very critical connection in the sanitary collection network. The existing 250 mm AC pipe has 10 years remaining in its anticipated useful life of 50 years.

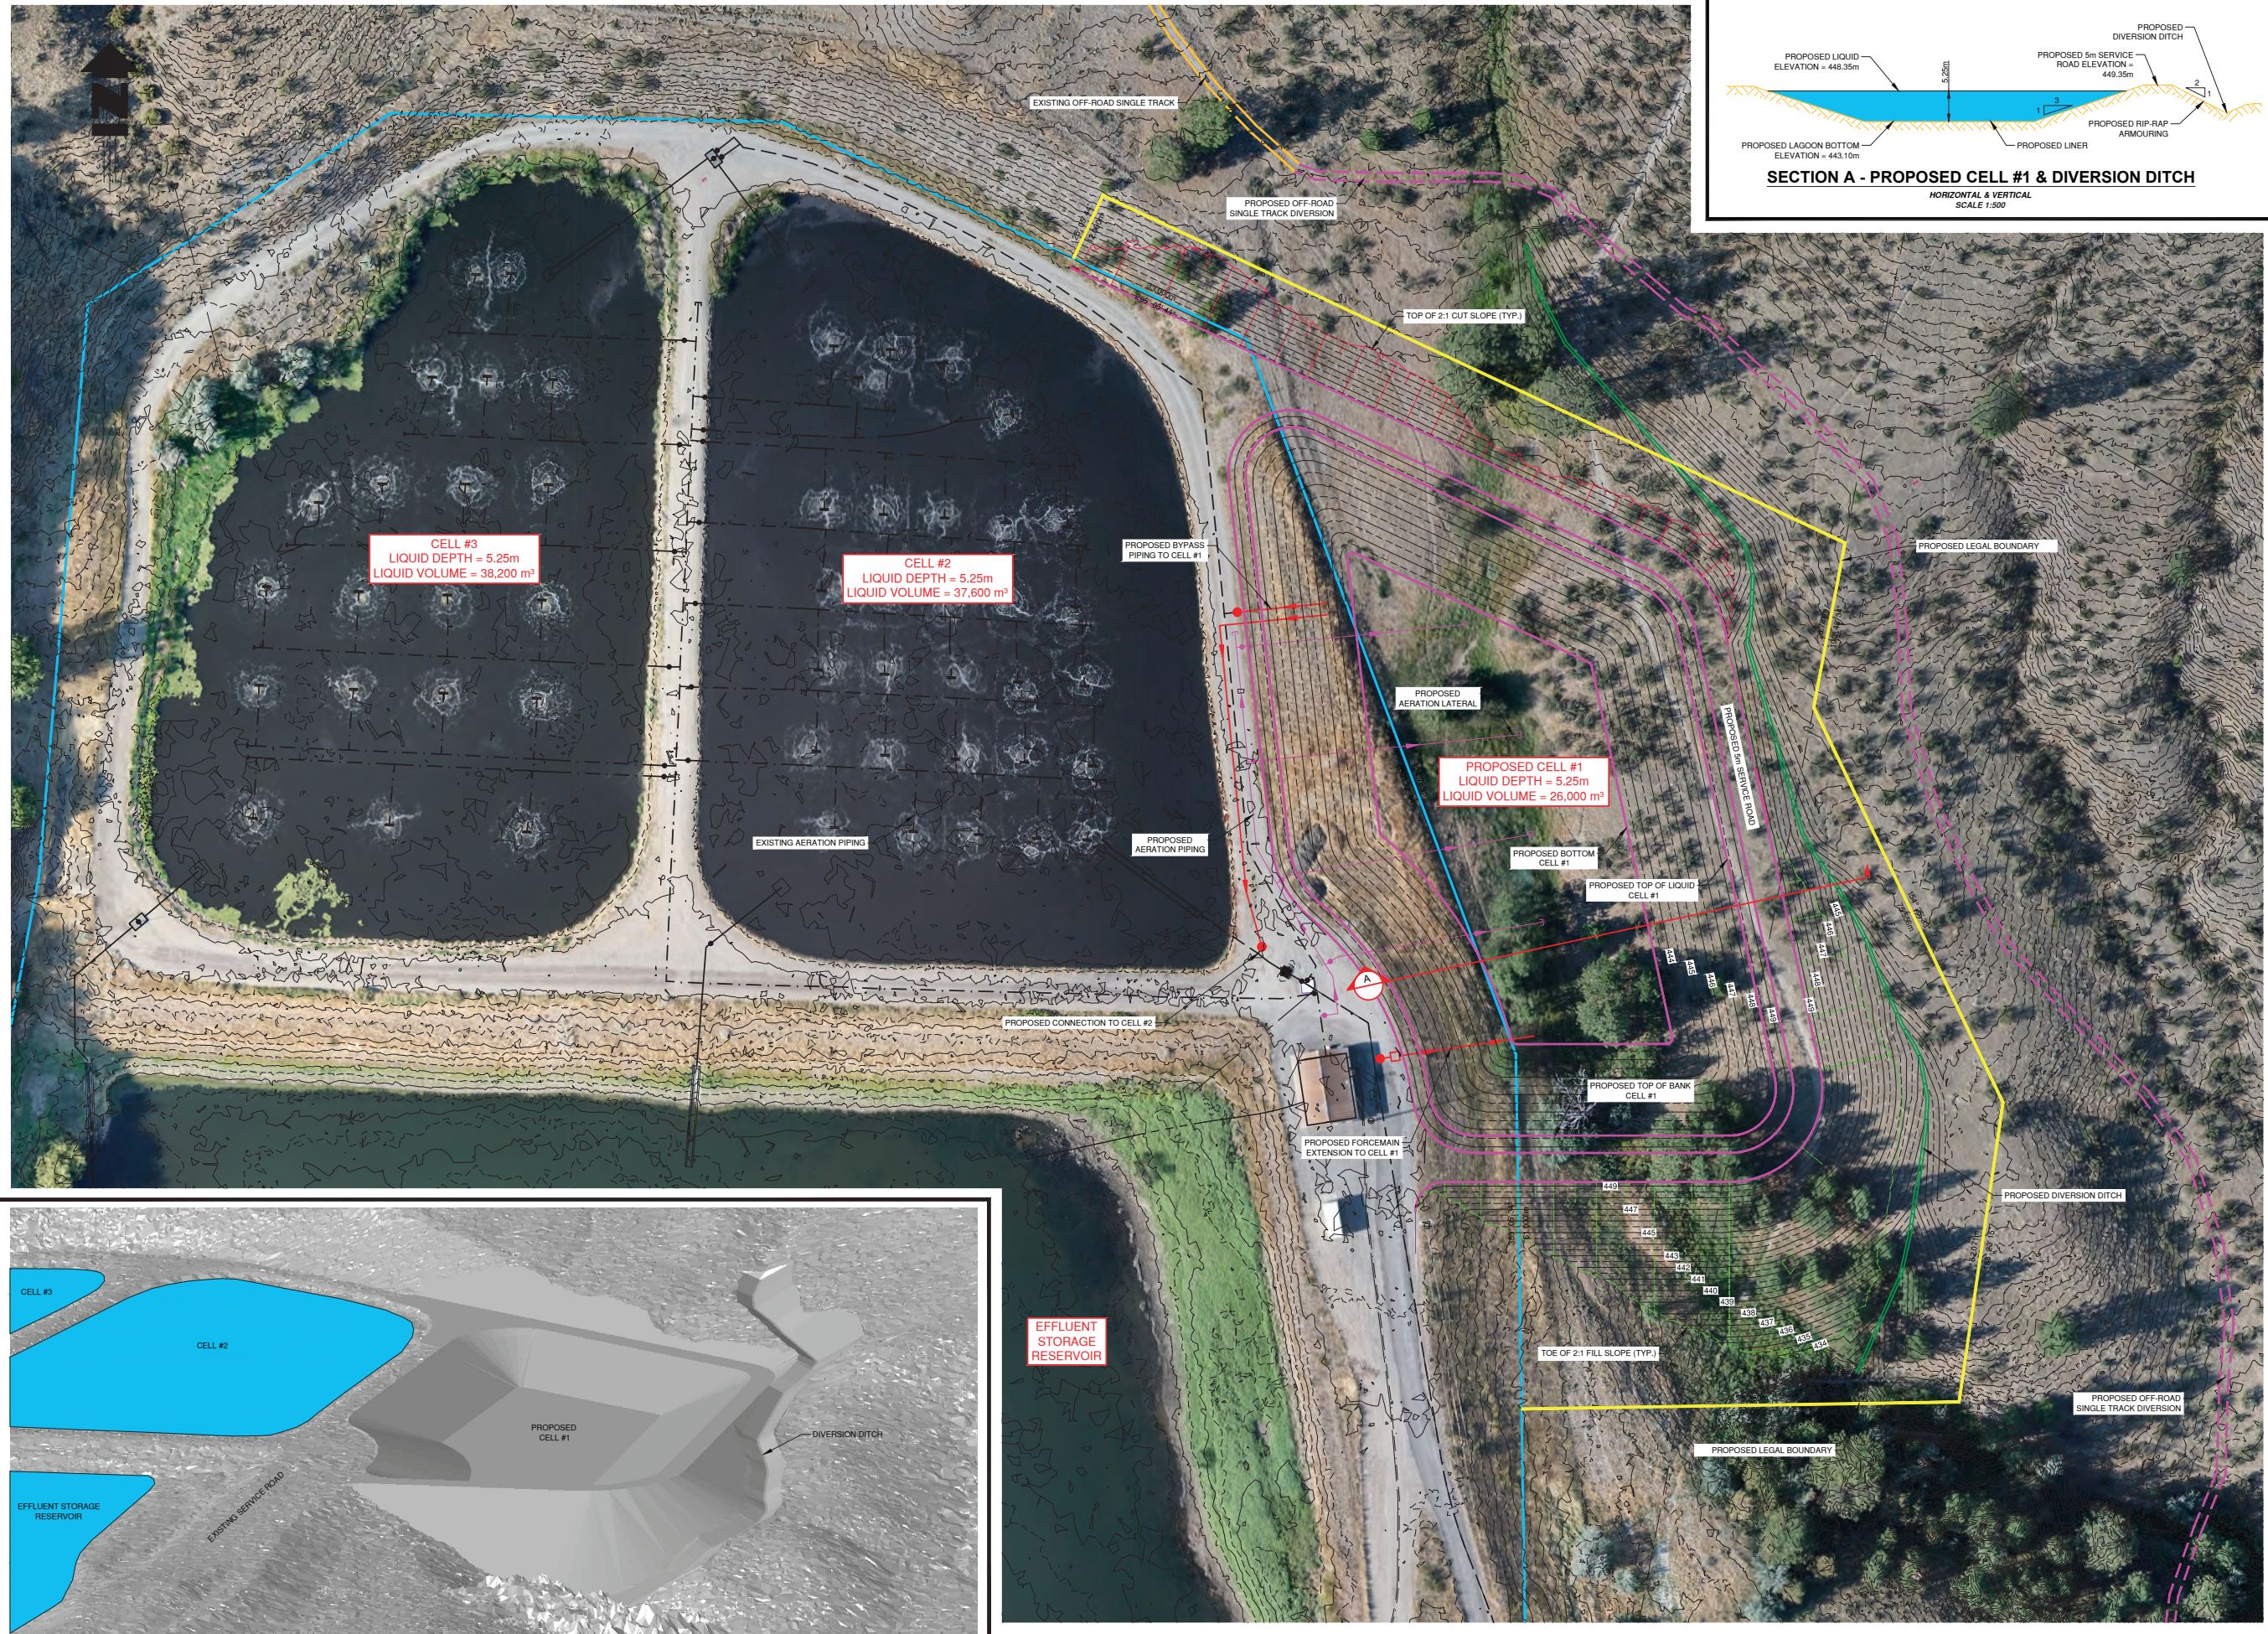
DRAWING No. **FIG 1-3** SHEET **1 OF 1**
 ISSUE-REV.

Figure 1-3 - Aerated Lagoon Treatment System Layout
and Intercell Piping

CUT/FILL QUANTITIES
 PROPOSED CELL #1 EARTHWORKS
 24,000 m³ (CUT)
 19,500 m³ (FILL)
 NET 4,500 m³ (CUT)
 NOT INCLUDING STRIPPING
 APPROXIMATE VOLUME 3,900 m³ (CUT)
 PROPOSED CELL #1 CAPACITY
 26,000 m³

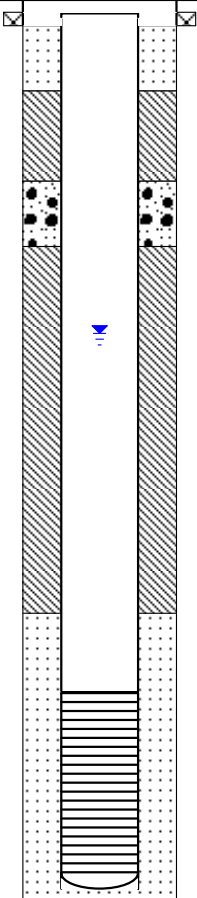
DEPTH (m)	LITHOLOGY DESCRIPTION	WELL CONSTRUCTION	WELL COMPLETION DETAILS
0	<p style="text-align: center;">Ground Surface</p> <p>SAND and GRAVEL, with some cobbles, coarse grained sand, small to large sub-rounded gravel, loose, poorly sorted, dry, brown.</p>

<p>Flushmount box, cemented in place</p> <p>0.1 m - 5.2 m below ground surface (bgs) Blank 2 inch diameter PVC with J-plug cap</p>
1	<p>SAND with some silt, minor clay, fine grained sand, loose, poorly sorted, dry, brown to grey. Organics (wood flecks) and mottling 2.3 m to 3 m.</p>		<p>0.2 m - 0.3 m bgs 10-20 Filter sand</p> <p>0.3 m - 1.2 m Surface seal, Enviroplug medium bentonite chips</p>
2	<p>SAND and SILT, fine grained sand, loose, poorly sorted, moist to wet at 5.2 m, dark grey</p>		<p>1.2 m - 1.8 m bgs Sand and Crush</p> <p>Water level 2.45 m (8.0 ft) below top of casing (btoc)</p>
3	<p>SAND and GRAVEL coarse and medium grained sand, small to large rounded gravel, loose, wet, brown.</p>		<p>1.8 m - 4.6 m bgs Bentonite chips</p>

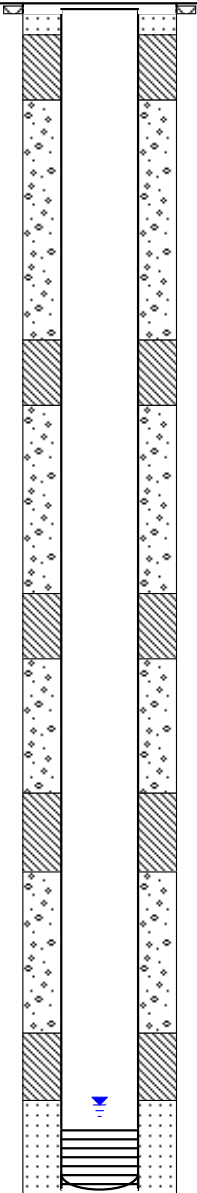
DEPTH (m)	LITHOLOGY DESCRIPTION	WELL CONSTRUCTION	WELL COMPLETION DETAILS
<p>0</p> <p>1</p> <p>2</p> <p>3</p> <p>4</p> <p>5</p> <p>6</p> <p>7</p> <p>8</p> <p>9</p> <p>10</p> <p>11</p> <p>12</p> <p>13</p> <p>14</p> <p>15</p> <p>16</p> <p>17</p> <p>18</p> <p>19</p> <p>20</p> <p>21</p> <p>22</p> <p>23</p> <p>24</p> <p>25</p> <p>26</p> <p>27</p> <p>28</p> <p>29</p>	<p style="text-align: center;">Ground Surface</p> <p>TOPSOIL</p> <p>GRAVEL with SAND, medium and coarse grained sand, small to large rounded to sub-rounded gravel, loose, poorly sorted, dry, brown. Mottling approximately 14.3 m and 21 m (47 ft and 68 ft) below ground surface.</p> <p>GRAVEL, small to large rounded to sub-rounded gravel, loose, wet, brown.</p> <p>SAND with some SILT, fine with some medium grained sand, loose, wet, brown.</p>

<p>Flushmount box, cemented in place</p> <p>0.1 m - 25.7 m bgs Blank 2 inch diameter PVC with J-plug cap</p> <p>0.2 m - 0.6 m bgs 10-20 Filter sand</p> <p>0.6 m - 2.1 m bgs Surface seal, Enviroplug medium bentonite chips</p> <p>2.1 m - 25 m bgs Alternating layers of approximately 1 m bentonite seal with 4.5 m of natural sluff</p> <p>Water level 25.1 m (82.3 ft) below top of casing (btoc) (May 6, 2021)</p> <p>25 m - 27.2 m bgs 10-20 Filter sand</p> <p>25.7 m - 27.2 m bgs 2 inch diameter 10 slot PVC screen 1.5 m (5 ft) length with bottom plug</p> <p>Total Well Depth 27.1 m btoc</p>

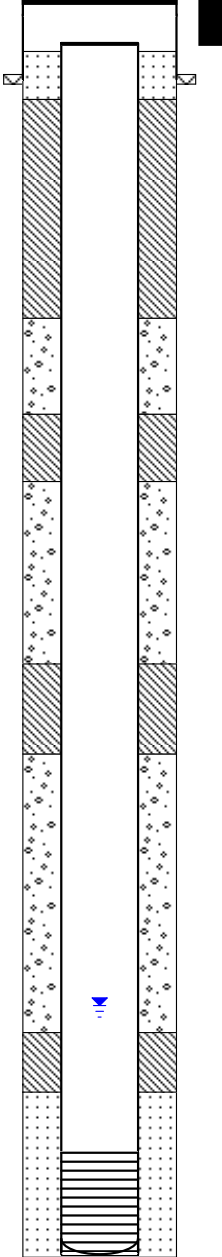
DEPTH (m)	LITHOLOGY DESCRIPTION	WELL CONSTRUCTION	WELL COMPLETION DETAILS
0 1 2 3 4 5 6 7 8 9 10 11 12 13 14 15 16 17 18 19 20 21 22 23 24 25 26 27 28 29 30 31	<p style="text-align: right;">Ground Surface</p> <p>0 - SAND with GRAVEL, fine and medium grained sand, small to large rounded to sub-rounded gravel, loose, poorly sorted, dry, brown.</p> <p>4 - SAND, with Silt lenses, fine and medium grained sand, loose, poorly sorted, dry, grey.</p> <p>9 - SAND with GRAVEL, fine and medium grained sand, small to large rounded to sub-rounded gravel, loose, poorly sorted, dry, brown.</p> <p>12 - SAND, fine grained, loose, well sorted, dry, brown.</p> <p>14 - SAND with GRAVEL, fine and medium grained sand, small to large rounded to sub-rounded gravel, loose, poorly sorted, dry, brown.</p> <p>17 - SAND, with compact Silt and Clay lenses, fine and medium grained sand, loose, poorly sorted, dry, grey.</p> <p>20 - SAND with GRAVEL, fine and medium grained sand, small to large rounded to sub-rounded gravel, loose, poorly sorted, dry, brown.</p> <p>23 - SAND, with compact Silt and Clay lenses, fine and medium grained sand, loose, poorly sorted, dry, grey.</p> <p>25 - SAND and SILT, fine grained sand, loose, poorly sorted, moist, brown. Increased moisture at 19.2 m, 20.7 m and 21 m (63 ft, 68 ft and 69 ft) bgs. Mottling throughout.</p>

<p>Well stick-up 0.86 m above ground surface (ags)</p> <p>0.86 m ags - 27.1 m below ground surface (bgs) Blank 2 inch diameter PVC with J-plug cap. Above ground lockabel monument casing, cemented in place</p> <p>0.7 m ags - 0.6 m bgs 10-20 Filter sand</p> <p>0.6 m - 6.1 m bgs Surface seal, Enviroplug medium bentonite chips</p> <p>6.1 m - 25.6 m bgs Alternating layers of approximately 1 m bentonite seal with 4.5 m of natural sluff</p> <p>Water level 25.1 m (82.3 ft) below top of casing (btoc) (May 6, 2021)</p> <p>25.6 m - 29.7 m bgs 10-20 Filter Sand</p> <p>27.1 m - 29.7 m bgs 2 inch diameter 10 slot PVC screen 3 m (10 ft) length with bottom plug</p> <p>Total Well Depth 30.6 m btoc</p>

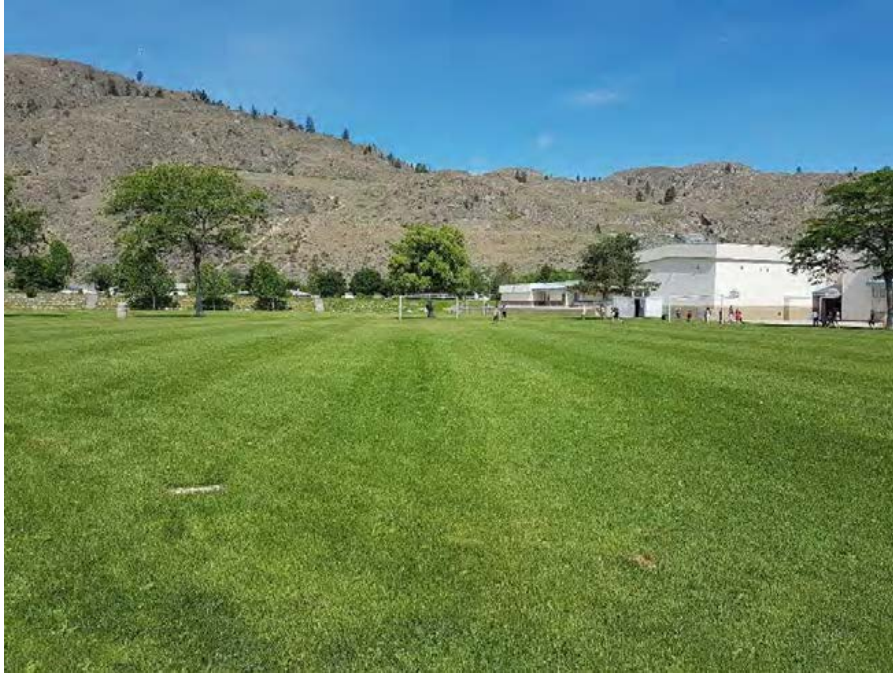
Photo 1. Sports field with turfgrass cover between elementary and high schools.

- The playing fields and park land located between Oliver Elementary School and South Okanagan High School (Figure 1 – maps and photos are at end of report). All of this parcel is currently covered with turfgrass and is irrigated with an underground sprinkler system (Photo 1). There are mature trees around the edges of the fields.
- Oliver Cemetery (Figure 2). The cemetery grounds are primarily vegetated with turfgrass (Photos 3 and 4) and are irrigated with underground sprinklers. Trees (mostly cedar) are planted around the property boundary, and there are some deciduous tree among the monuments.
- Oliver Community Park located immediately east of the Okanagan River on Fairview Road (Figure 3). The park includes three baseball/softball fields, a lawn bowling green, and areas for walking and sitting. The ground cover is turfgrass and there are a number of mature trees in the

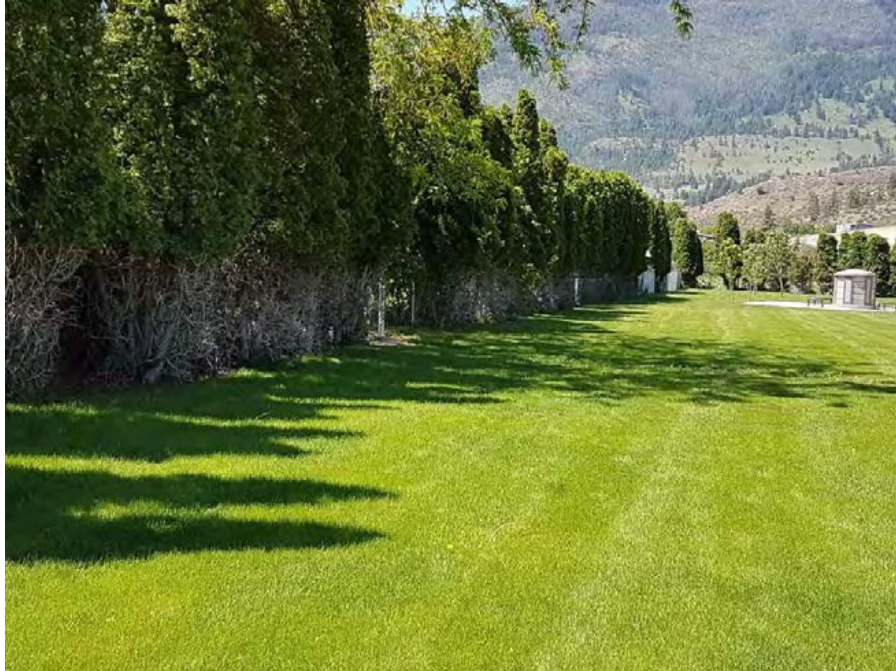
Photo 3: Lawn area along cemetery boundary, currently irrigated.

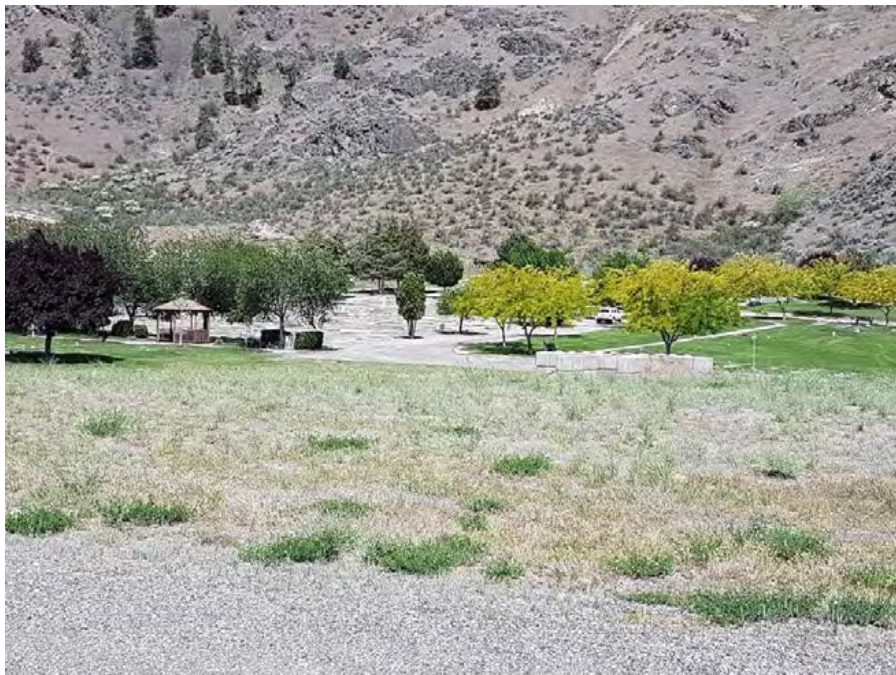
Photo 4: Cemetery overview showing unirrigated and irrigated (background) areas.

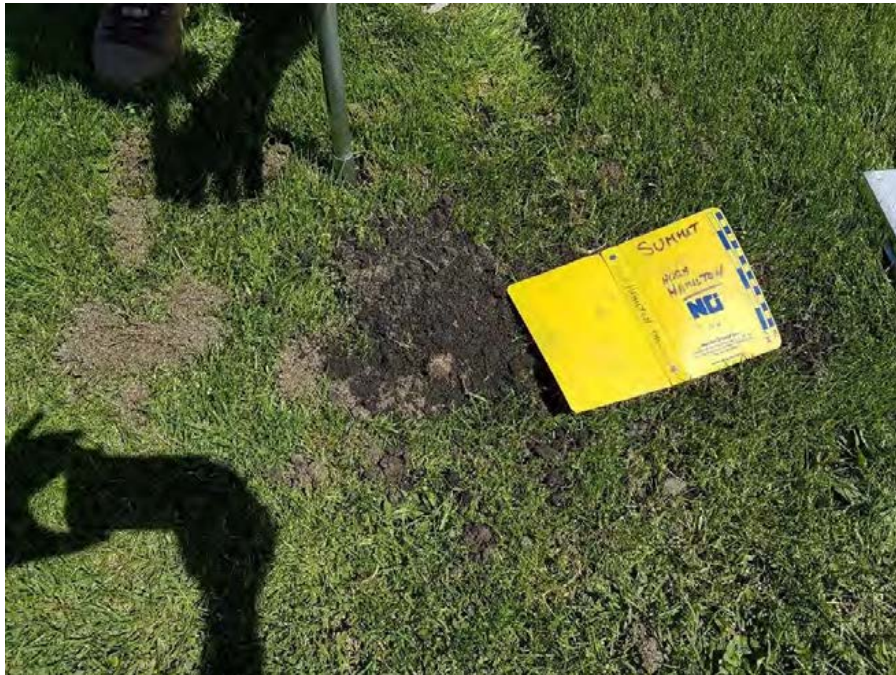
Photo 6: Example of silty soil in north part of Oliver Community Park

Soil information for the subject property was obtained from the BC Soil Information Finder Tool (SIFT). Figures 1 to 4 show the spatial distribution of soil types on the planned irrigation sites, and the soil properties are summarized in Table 1. Soils at the school and airport sites are mapped by BC as 100% Rutland soils, which are classified as Orthic Dark Brown Chernozems, developed on glacio-fluvial deposits. They typically are gravelly with a sandy or sandy loam surface texture (Photo 2). Soils at the cemetery are Ponderosa soils developed on alluvial fan deposits with a fluvial veneer. They are classified as Rego Dark Brown Chernozems and are also gravelly within sandy loam. The soils in the park have been developed on fluvial and floodplain deposits. About 90% of the irrigated area is classified as Kinney soils and are Gleyed Regosols (signifying that they are relatively young and that the soil profile is routinely saturated for an extended period). The northwest part of the park as mapped as Cawston soils, a Rego Gleysol (indicating somewhat greater soil profile development but also routinely saturated). The Kinney soils have a sandy loam or loam texture with some silt lenses, while the Cawston soil is a silt loam (Photo 6).

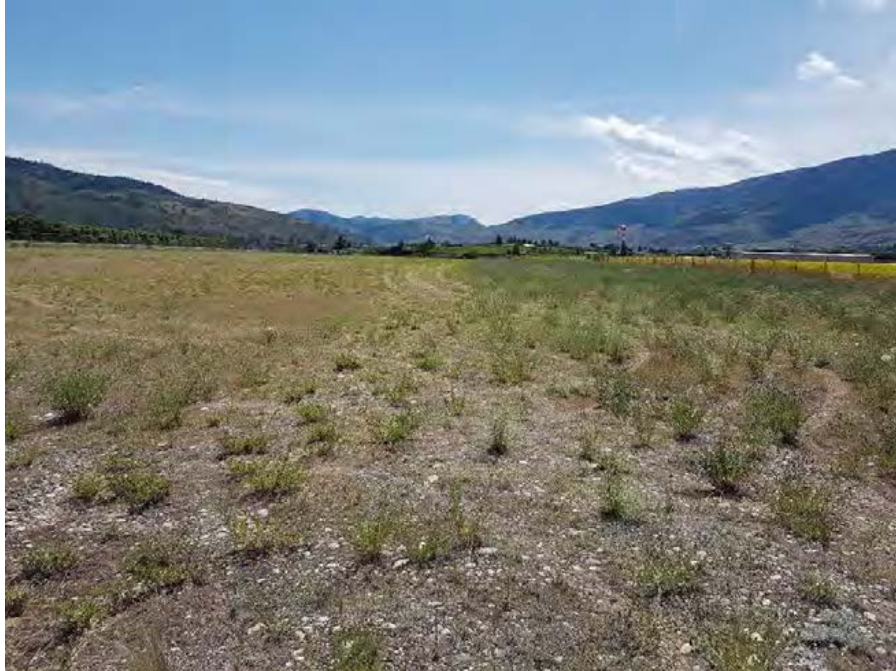
Photo 7: Proposed new irrigation area at airport. Note exposed sub-soil and relatively sparse vegetative cover [Land on right side of photo may receive some irrigation water from fields near runway (yellow flowers)].

- Oliver Municipal Airport (Map 4). The new irrigation area is the strip of industrial-zoned land on the east side of the runway (Photo 7). The fields surrounding the runway to the west are already authorized for reclaimed water irrigation. The new irrigation area is mostly unoccupied although some parts are used for storage and there is one building. It appears that the topsoil was stripped from parts of the site and transported off-site. Vegetation cover is limited (about 25-50% on average) and includes alfalfa, agronomic and native grasses, and invasive species (see Section 4). It is not currently irrigated.

The soil properties observed in the field were consistent with the existing BC mapping, indicating that the published soil information (SIFT) can be relied upon for irrigation planning. The key exception is the land on the airport site where the topsoil (likely the Ap horizon¹ or the combined A and B horizons appear to have been stripped off in places, exposing the underlying gravelly BC or C horizon that is characteristic of the Rutland soil (Wittneben 1986). This was confirmed by digging a soil pit on the west side of the fence in the alfalfa field that surrounds the runway, where a dark brown Ap horizon (~0.3 m thick) was present (Photo 8). At the airport site there is considerable gravel exposed on the surface among pockets of thin sandy soil. The vegetation cover is sparse (Photos 7, 9 and 10).

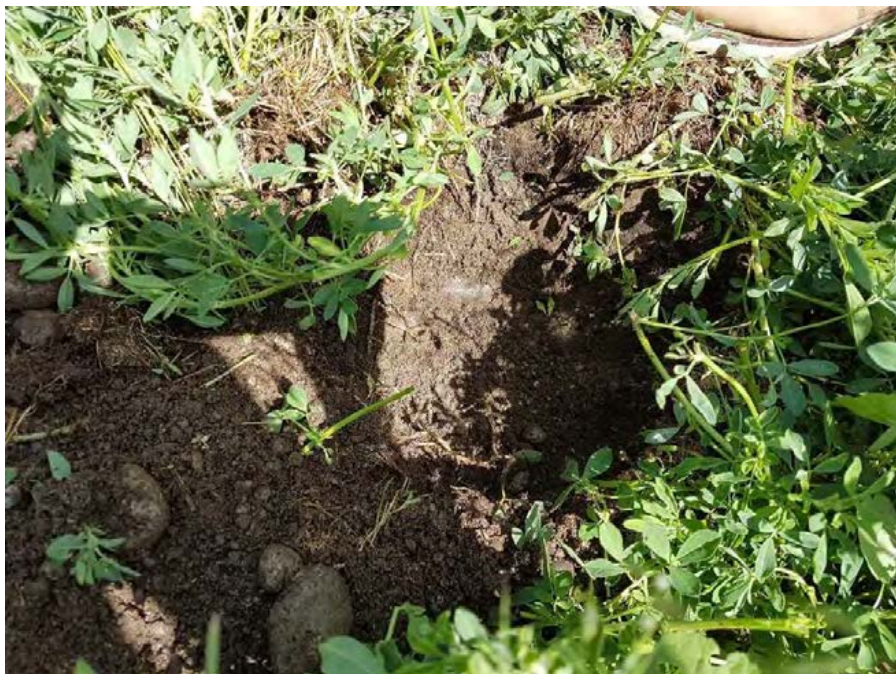
Photo 8: Surface soil in irrigated fields. Note intact dark upper horizon and presence of gravel throughout.

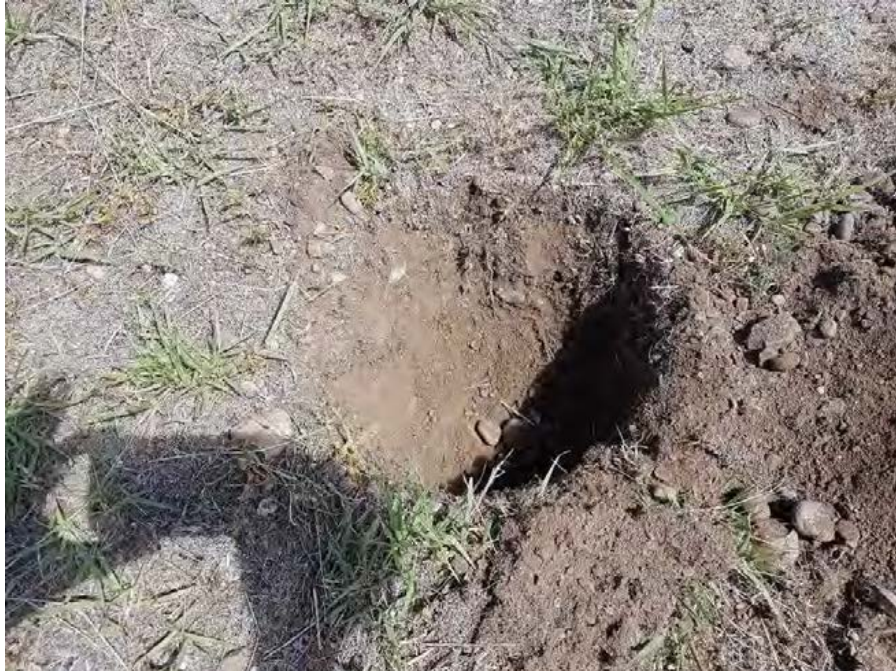
Photo 9: Soil pit on proposed irrigation area at airport. At this location, a residual A/Ap horizon is present. Note fine roots in upper 10 cm.

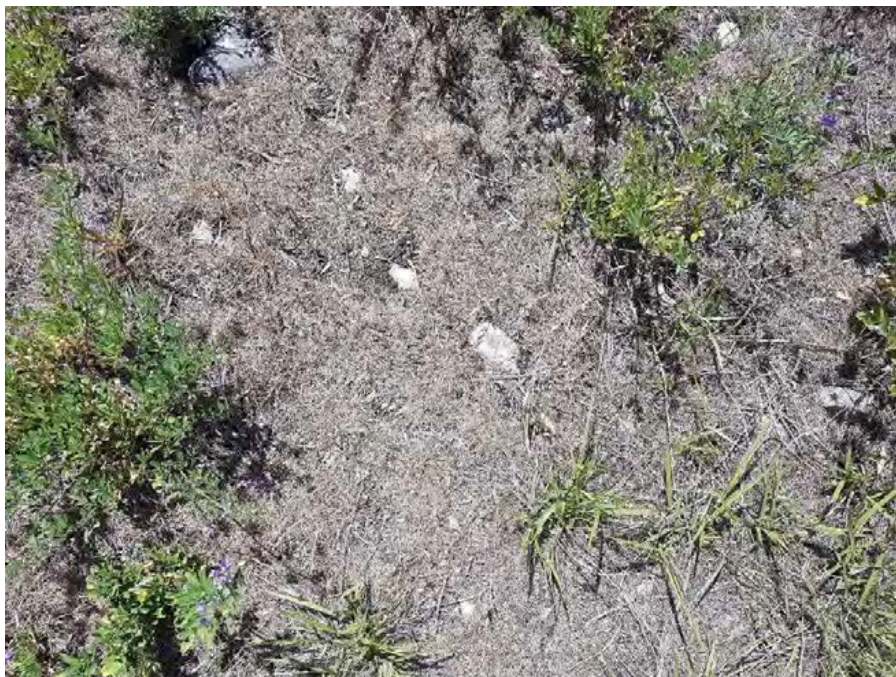
Photo 10: Ground surface at new airport irrigation area where topsoil may have been partially removed. Note how alfalfa plants are green as their roots obtain moisture from deep within soil.

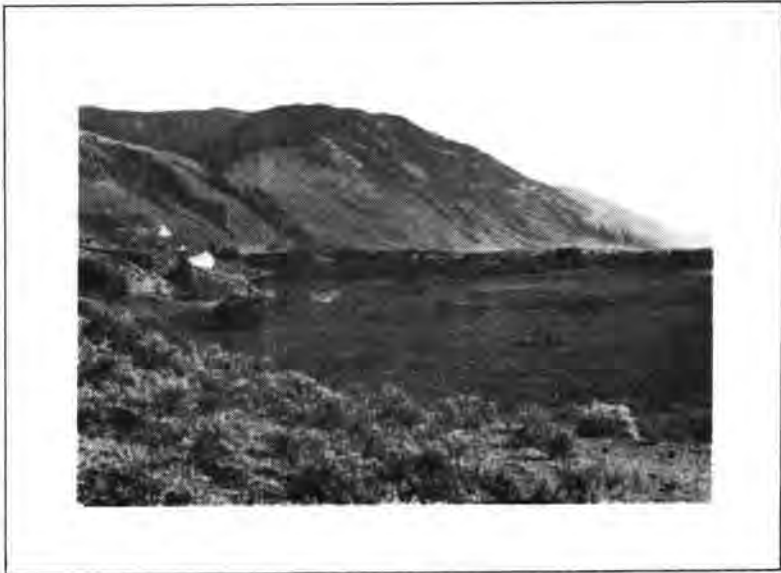
Cawston soils in association with Chopaka and Keremeos soils occupy the gently undulating middle portion of the photo.
