Sanitary Sewer System 2023 Annual Report

Town of Oliver

February 2024

Project No. 302-088-011

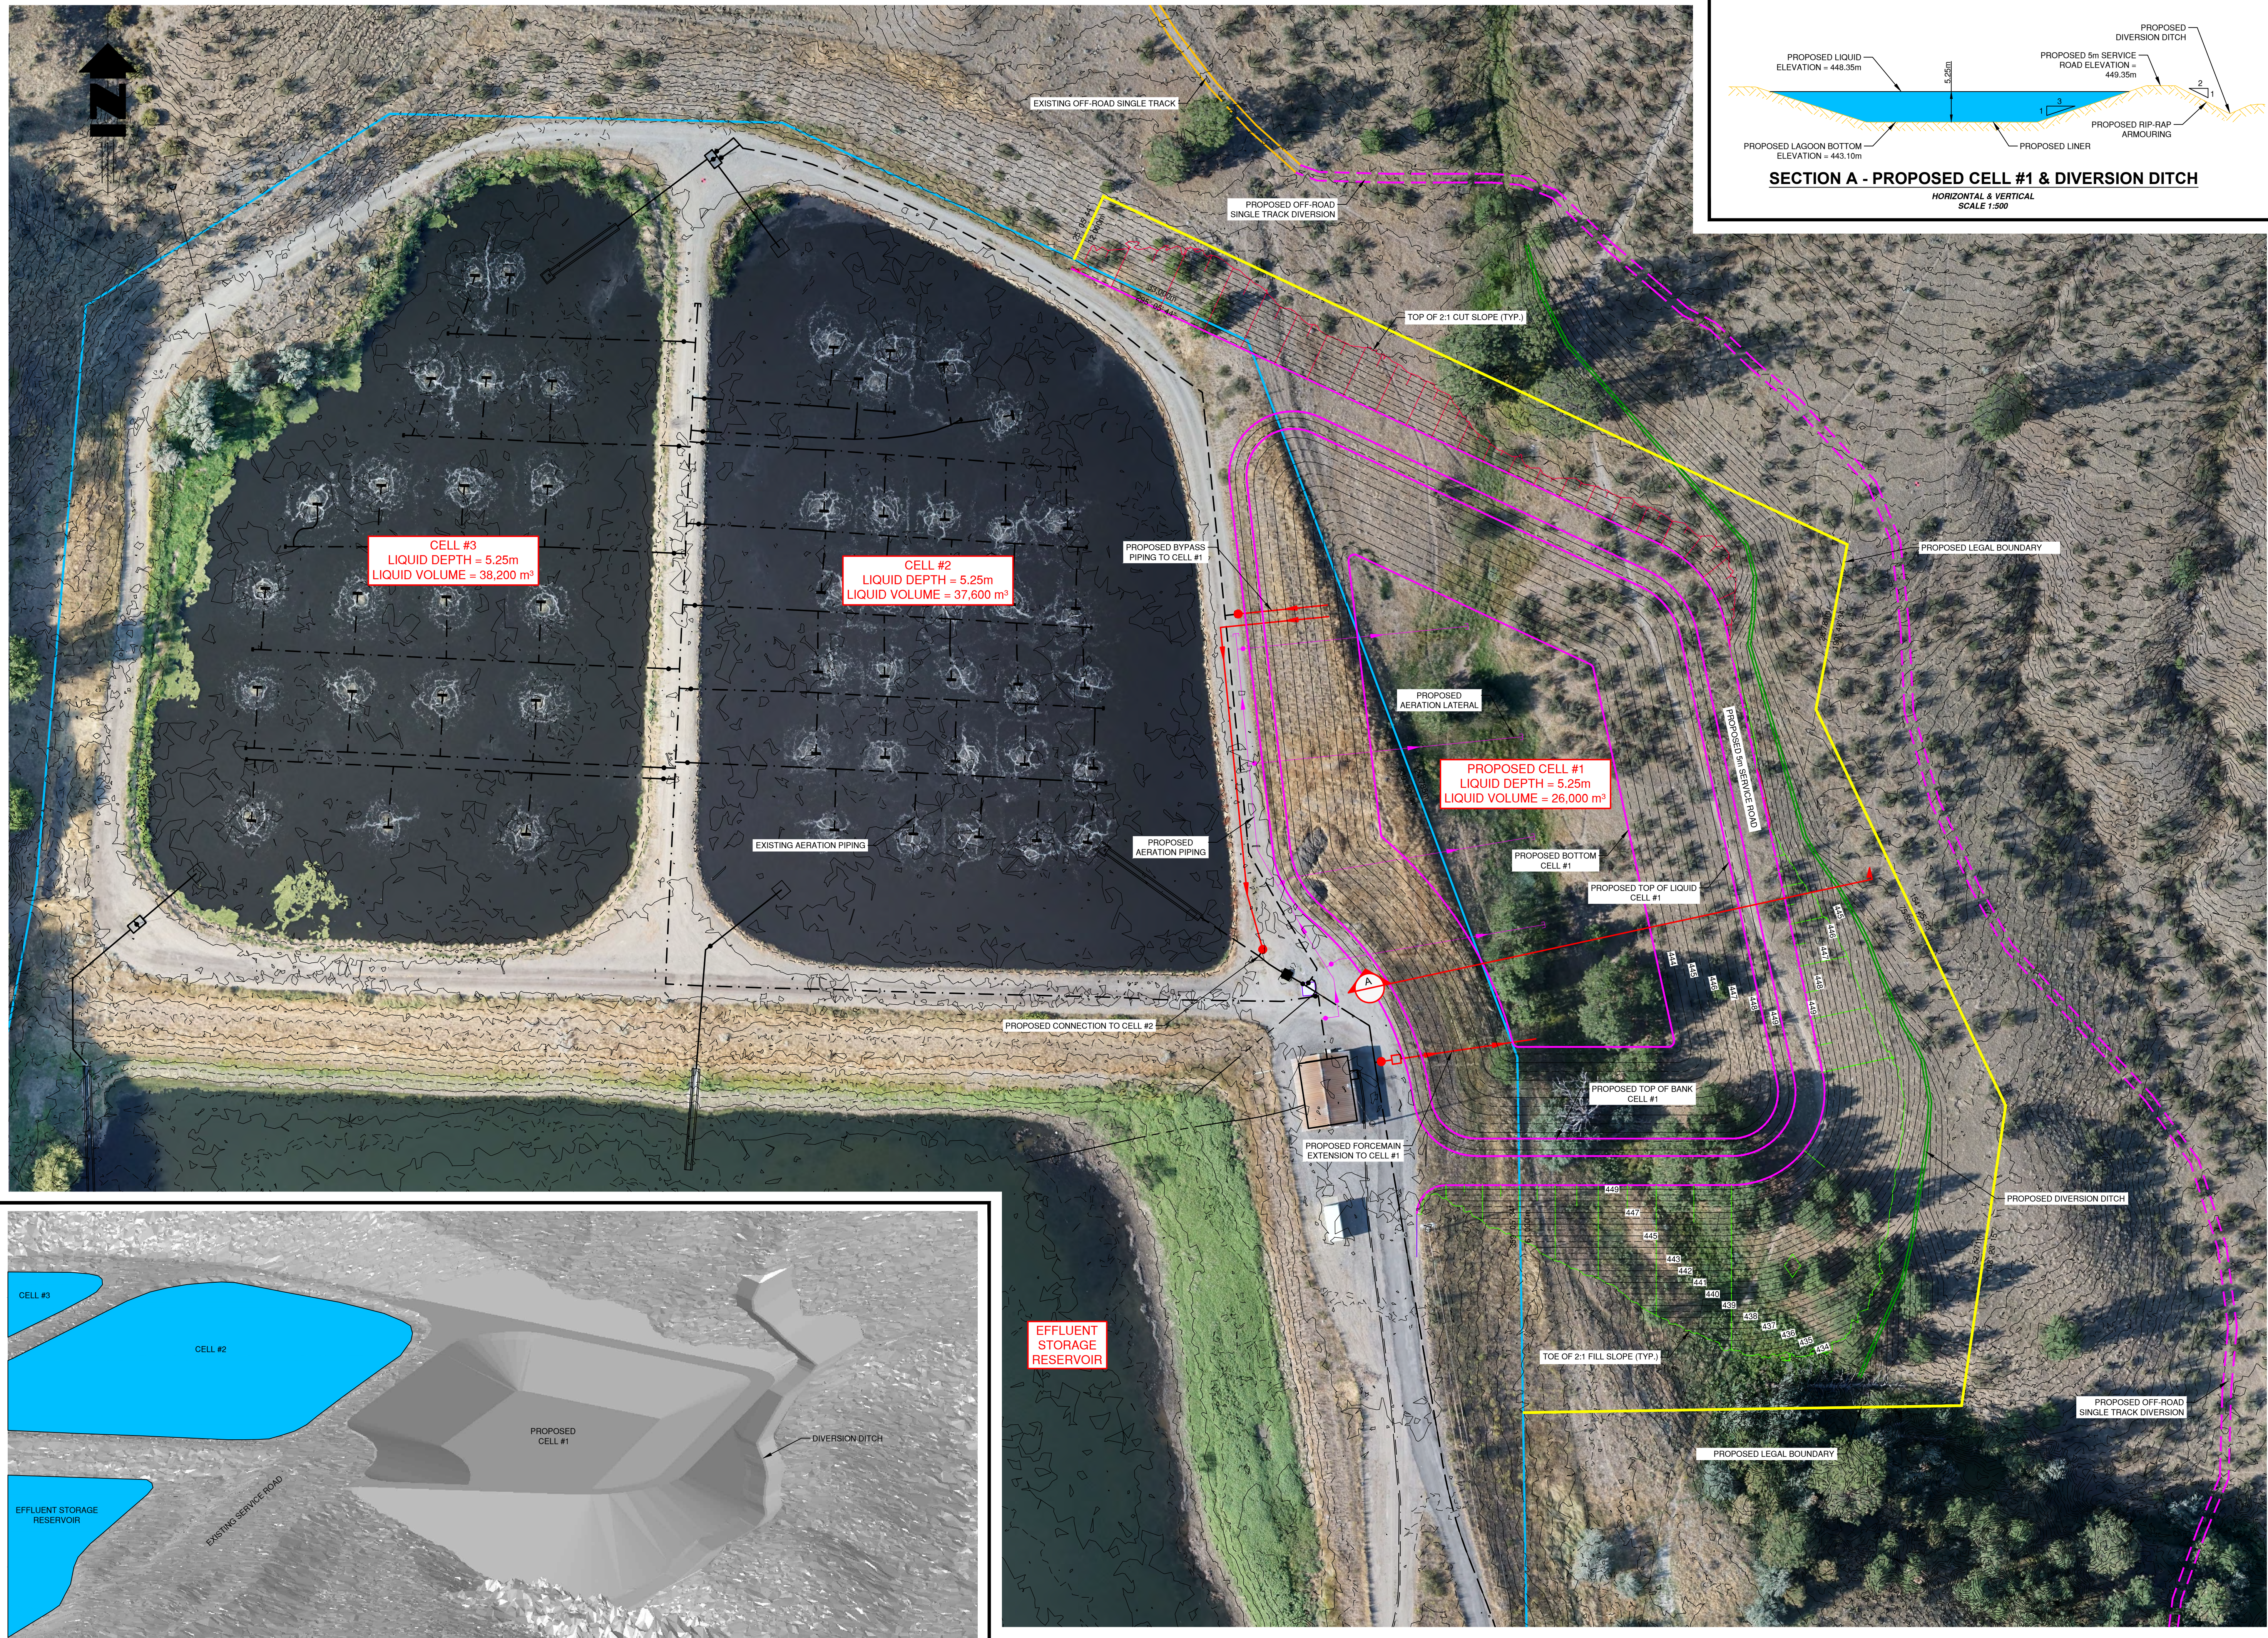
CUT/FILL QUANTITIES	
PROPOSED CELL #1 EARTHWORKS	
24,000 m³ (CUT)	
19,500 m³ (FILL)	
NET 4,500 m³ (CUT)	
NOT INCLUDING STRIPPING	
APPROXIMATE VOLUME 3,900 m³ (CUT)	
PROPOSED CELL #1 CAPACITY	
26,000 m³

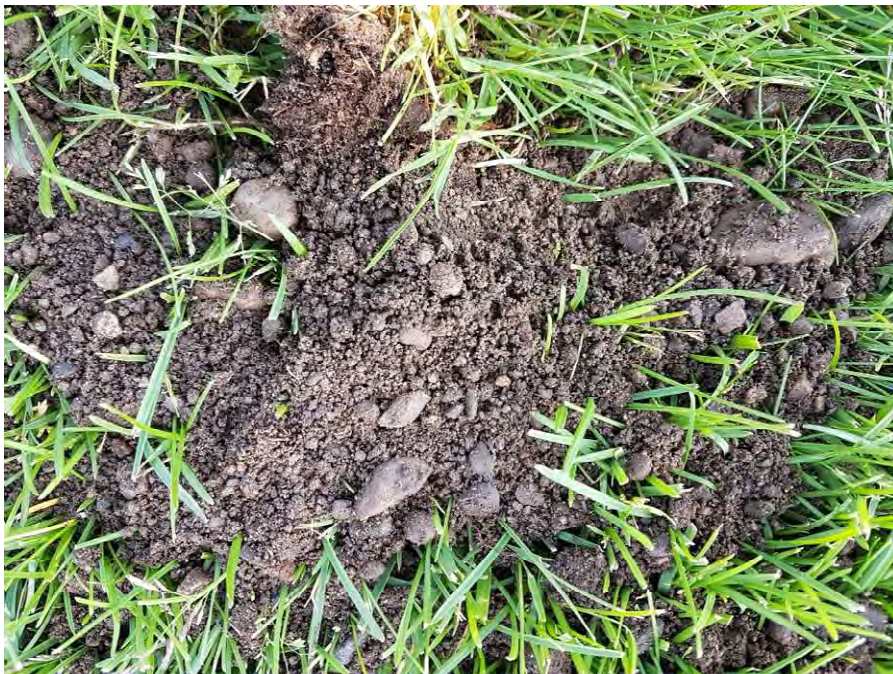
Photo 2: Typical surface soil (~4-20 cm below surface) at school site.

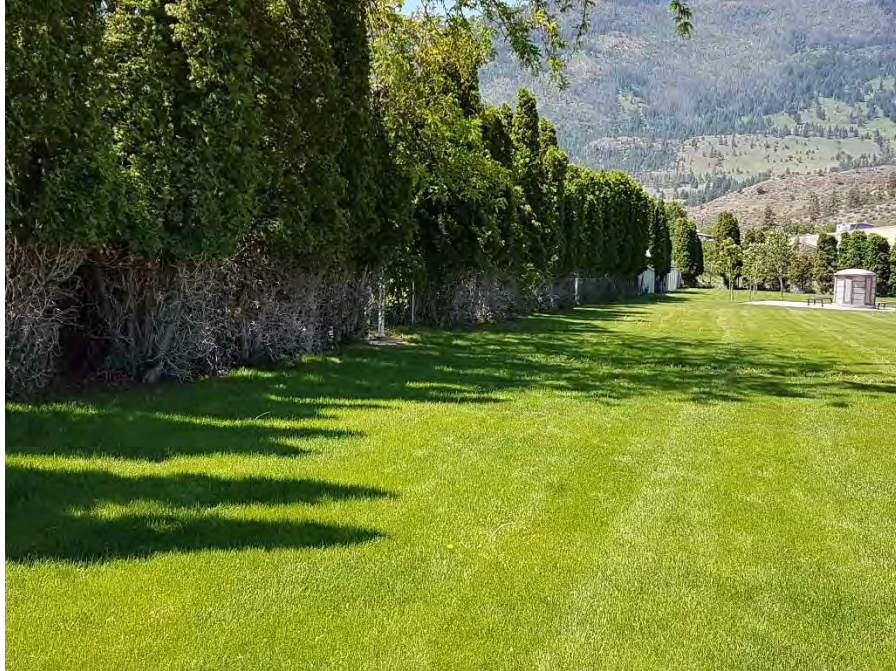
Photo 3: Lawn area along cemetery boundary, currently irrigated.

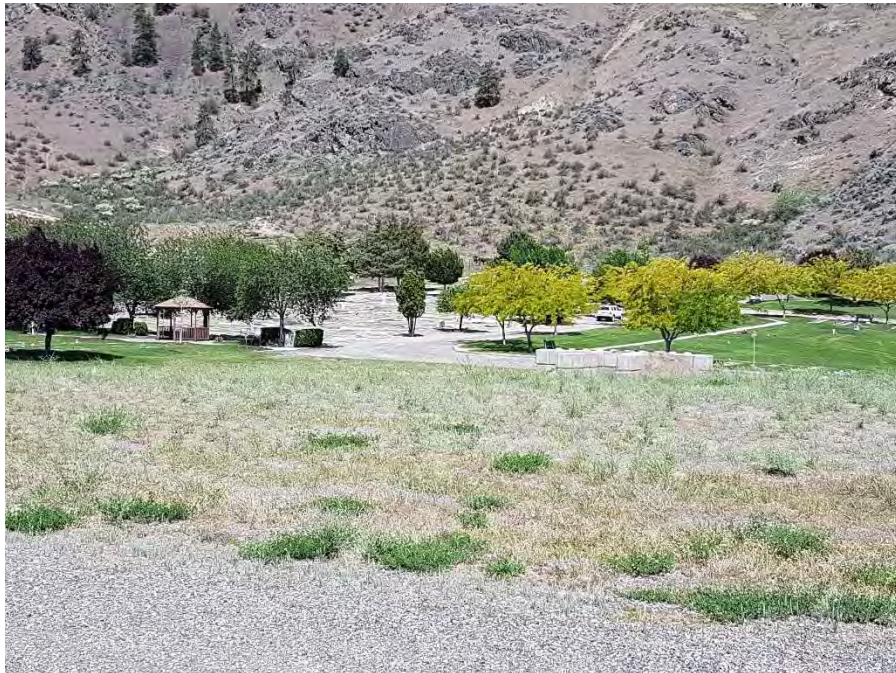
Photo 4: Cemetery overview showing unirrigated and irrigated (background) areas.

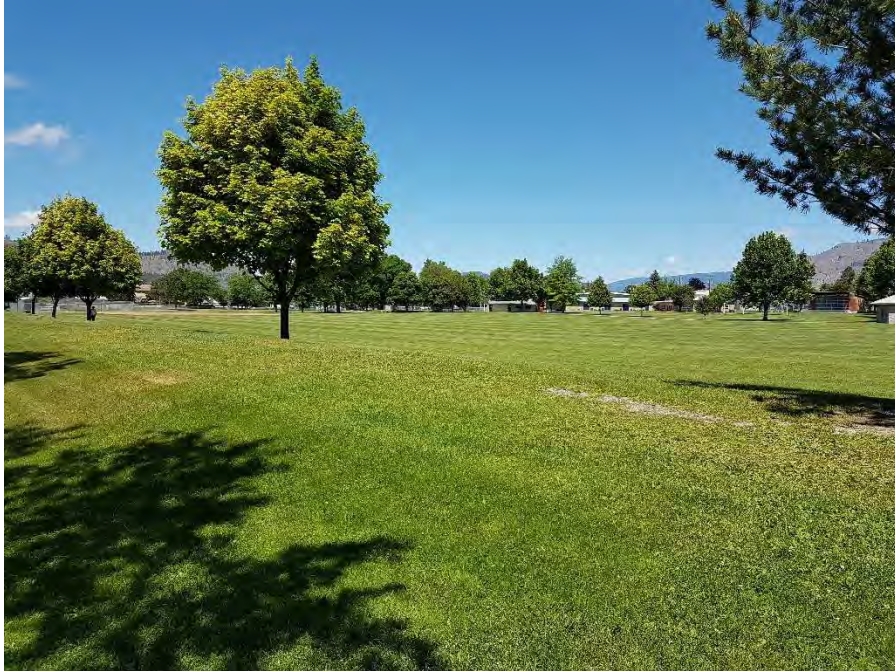
Photo 5: Oliver Community Park from dike looking northeast.

areas outside the ball fields and on the small area on the north side of Fairview Road (Photo 5). The park is irrigated with an underground sprinkler system.

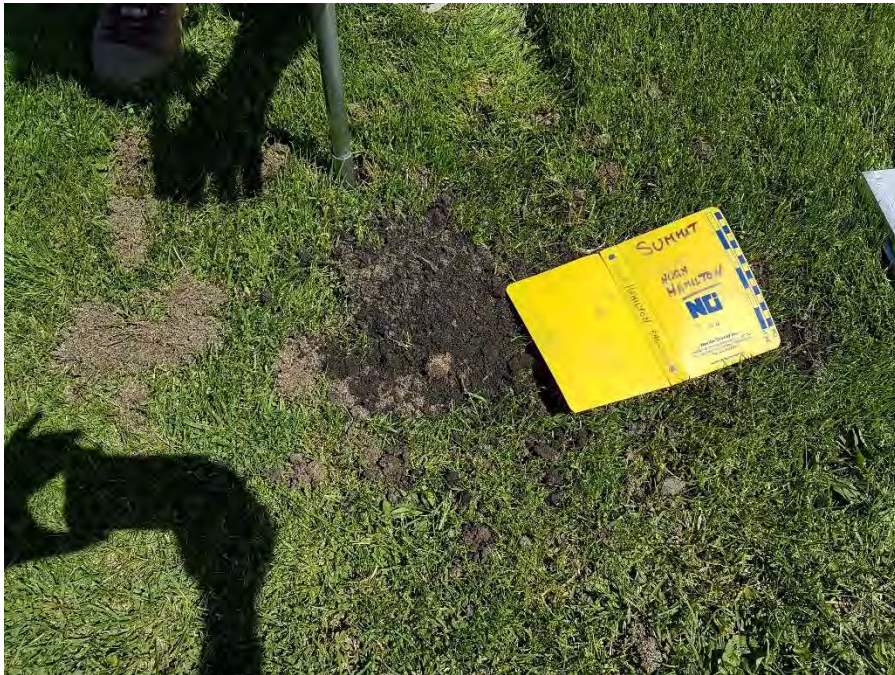
Photo 6: Example of silty soil in north part of Oliver Community Park

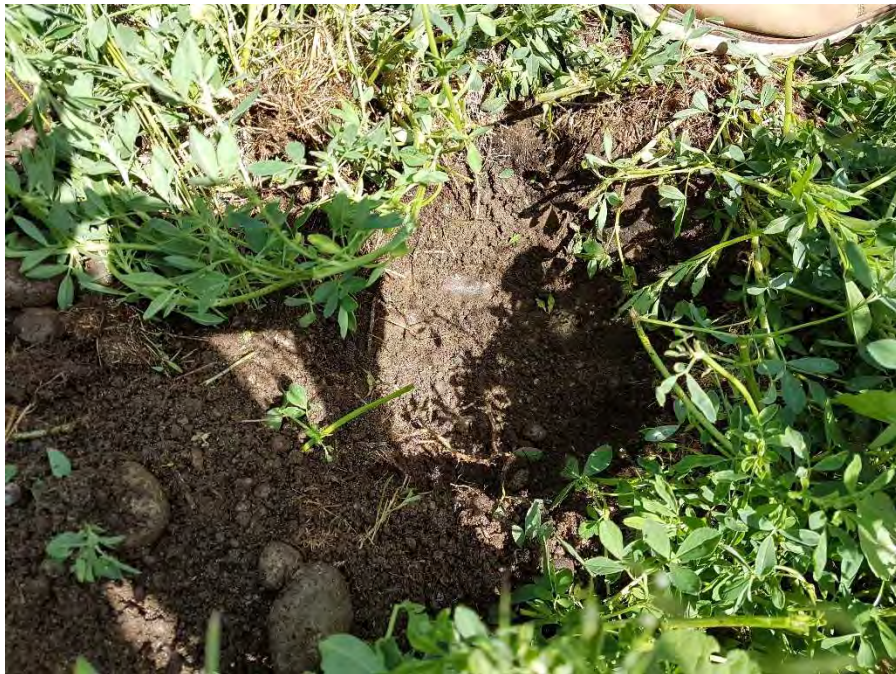
Photo 8: Surface soil in irrigated fields. Note intact dark upper horizon and presence of gravel throughout.

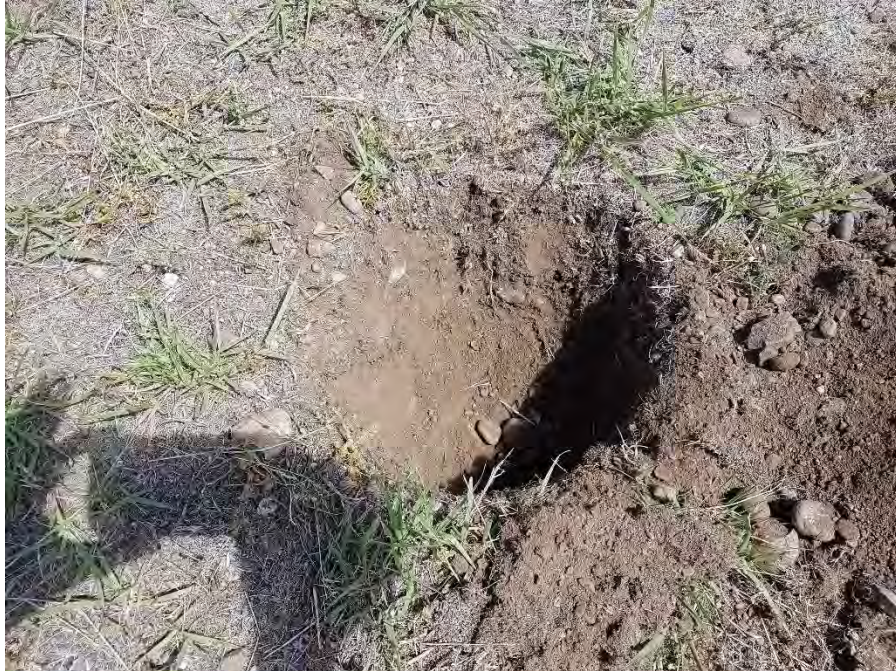
Photo 9: Soil pit on proposed irrigation area at airport. At this location, a residual A/Ap horizon is present. Note fine roots in upper 10 cm.

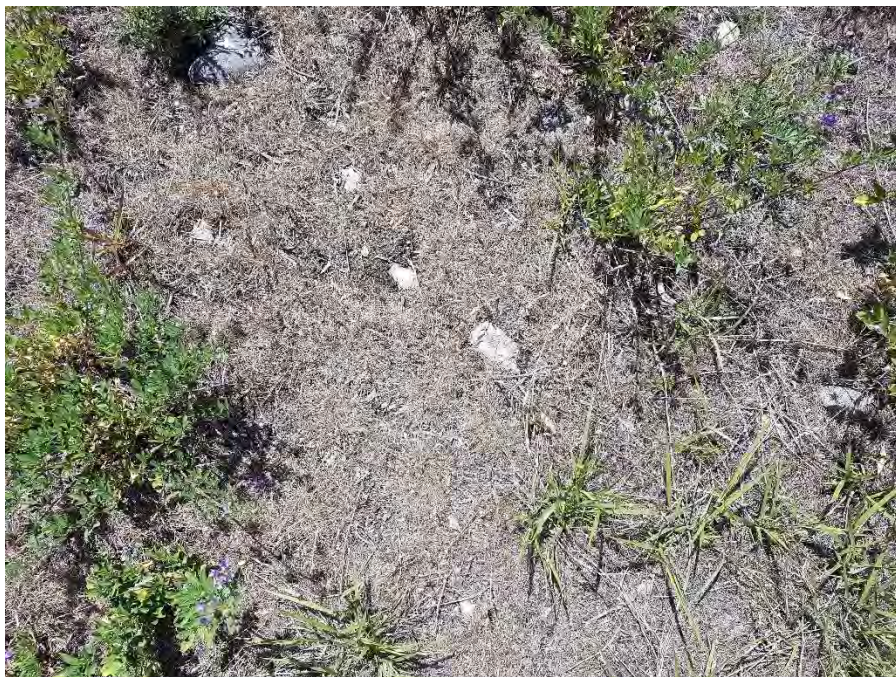
Photo 10: Ground surface at new airport irrigation area where topsoil may have been partially removed. Note how alfalfa plants are green as their roots obtain moisture from deep within soil.

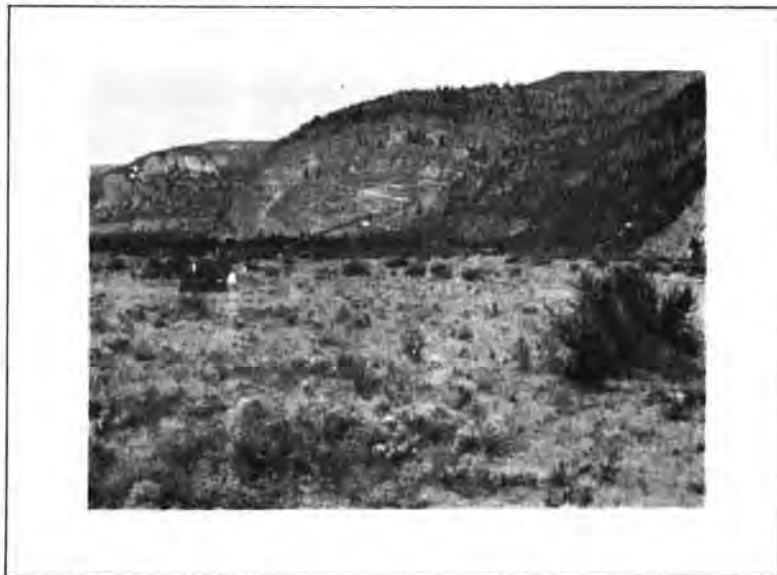
A very gently sloping area of undeveloped Rutland soils north-east of Oliver.

Rutland soils are well suited for urban and related uses. They are rapidly drained, have high bearing capacity and generally level topography. The depth of topsoil is shallow. Effluent from septic field installations may be incompletely filtered by the very gravelly, coarse-textured subsoil.

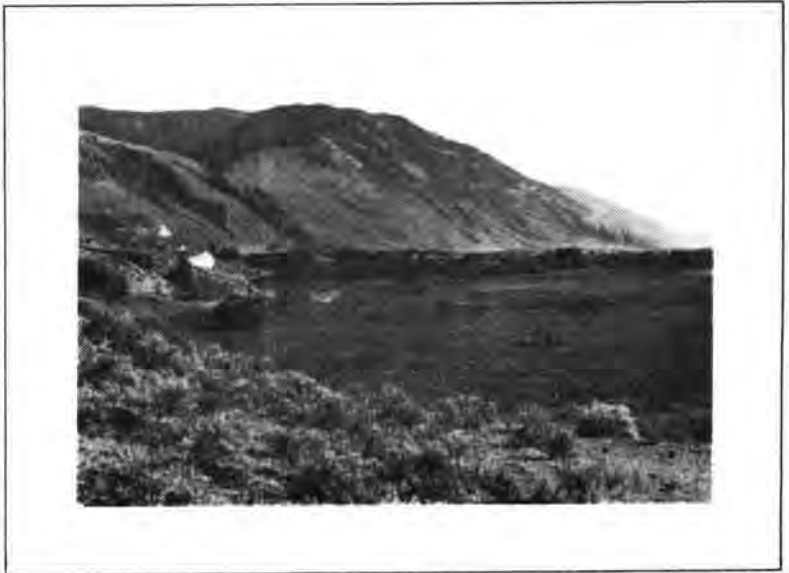
Cawston soils in association with Chopaka and Keremeos soils occupy the gently undulating middle portion of the photo.

Cawston soils have developed in medium textured recent fluvial deposits generally between 50 and 100 cm thick overlying moderately coarse textured materials. Surface and subsurface textures are silt loam or loam. Subsoil texture are usually gravelly sandy loam or gravelly loamy sand. The soils are poorly to imperfectly drained. They are moderately pervious, have a high water holding capacity and slow surface runoff.

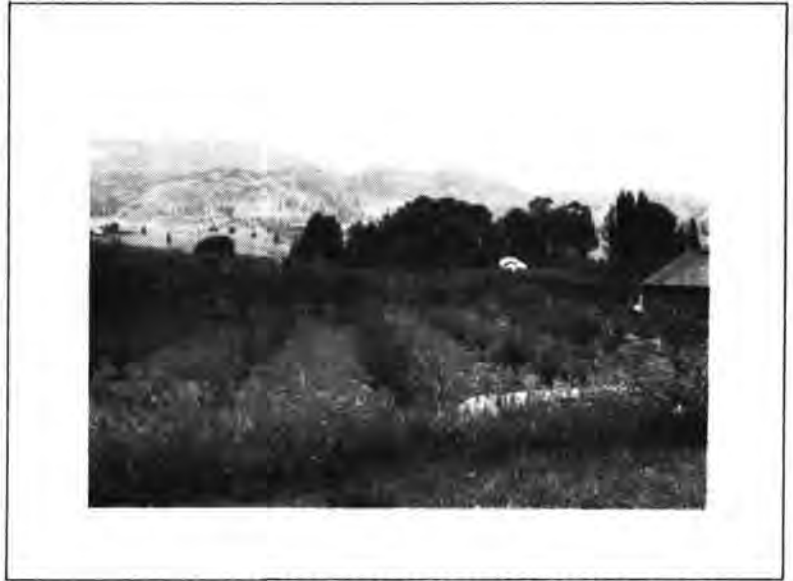
A typical view of moderately sloping Ponderosa soils near Oliver.

Except for a few steeply sloping areas, Ponderosa soils are moderately well suited for most urban and related uses. Incomplete septic tank effluent filtration may occur in the coarse-textured subsoils.
