# Sanitary Sewer System 2024 Annual Report

Town of Oliver

April 2025

Project No. 306-088-012

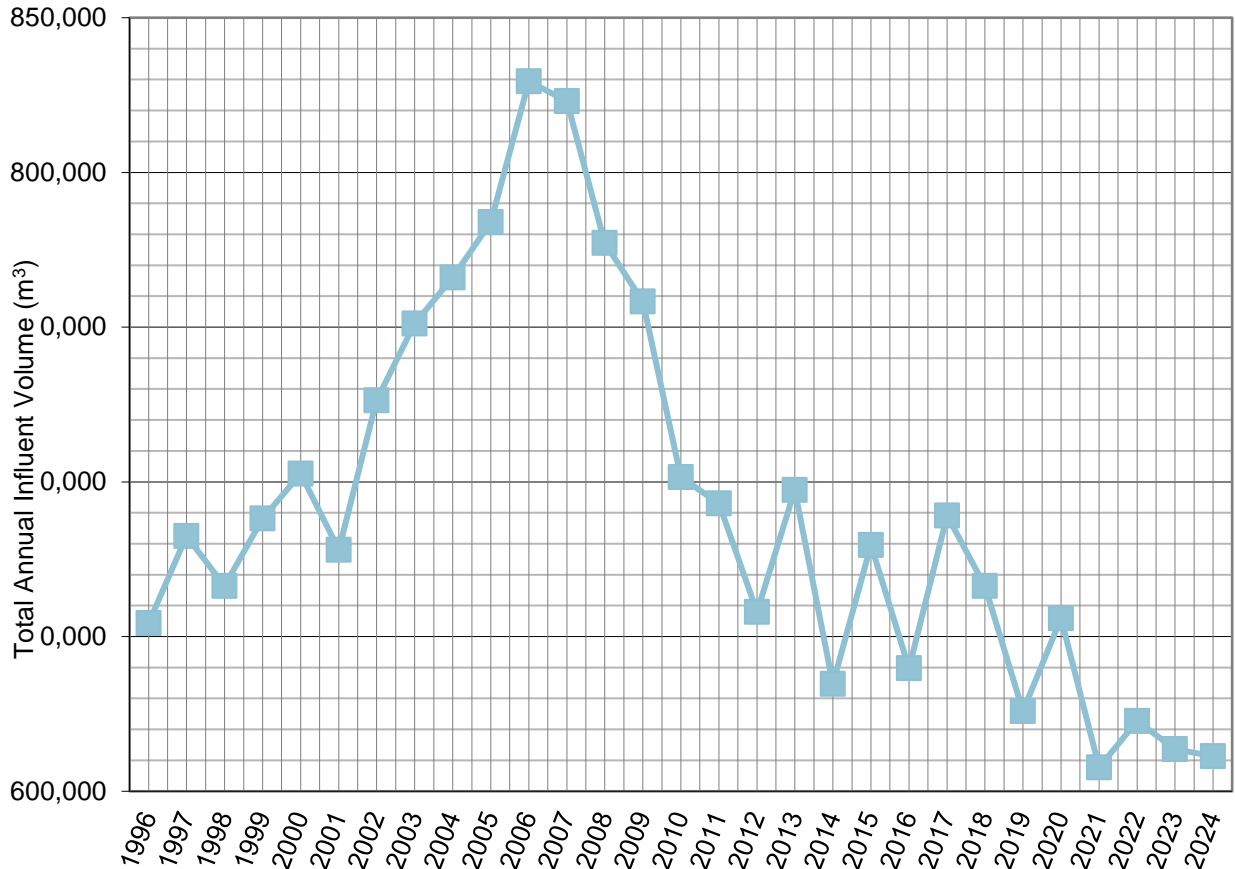
**FIGURE 1-3: TOTAL ANNUAL INFLUENT SEWAGE FLOWS FOR 1996 AND 2024**

<b>Year</b>	<b>Total Influent Volume (m<sup>3</sup>)</b>	<b>Average Daily Flow (m<sup>3</sup>/d)</b>
1996	654,361	1,788
1997	682,480	1,870
1998	666,322	1,826
1999	688,193	1,885
2000	702,688	1,920
2001	678,052	1,858
2002	726,354	1,990
2003	751,139	2,058
2004	766,048	2,093
2005	783,947	2,148
2006	829,413	2,272
2007	823,011	2,255
2008	777,154	2,123
2009	758,308	2,078
2010	701,475	1,922
2011	693,045	1,899
2012	658,002	1,798
2013	697,377	1,911
2014	634,649	1,739
2015	679,542	1,862
2016	639,794	1,753
2017	689,098	1,888
2018	666,376	1,826
2019	625,911	1,715
2020	655,853	1,792
2021	607,731	1,665
2022	622,711	1,706
2023	613,563	1,681
2024	611,269	1,670

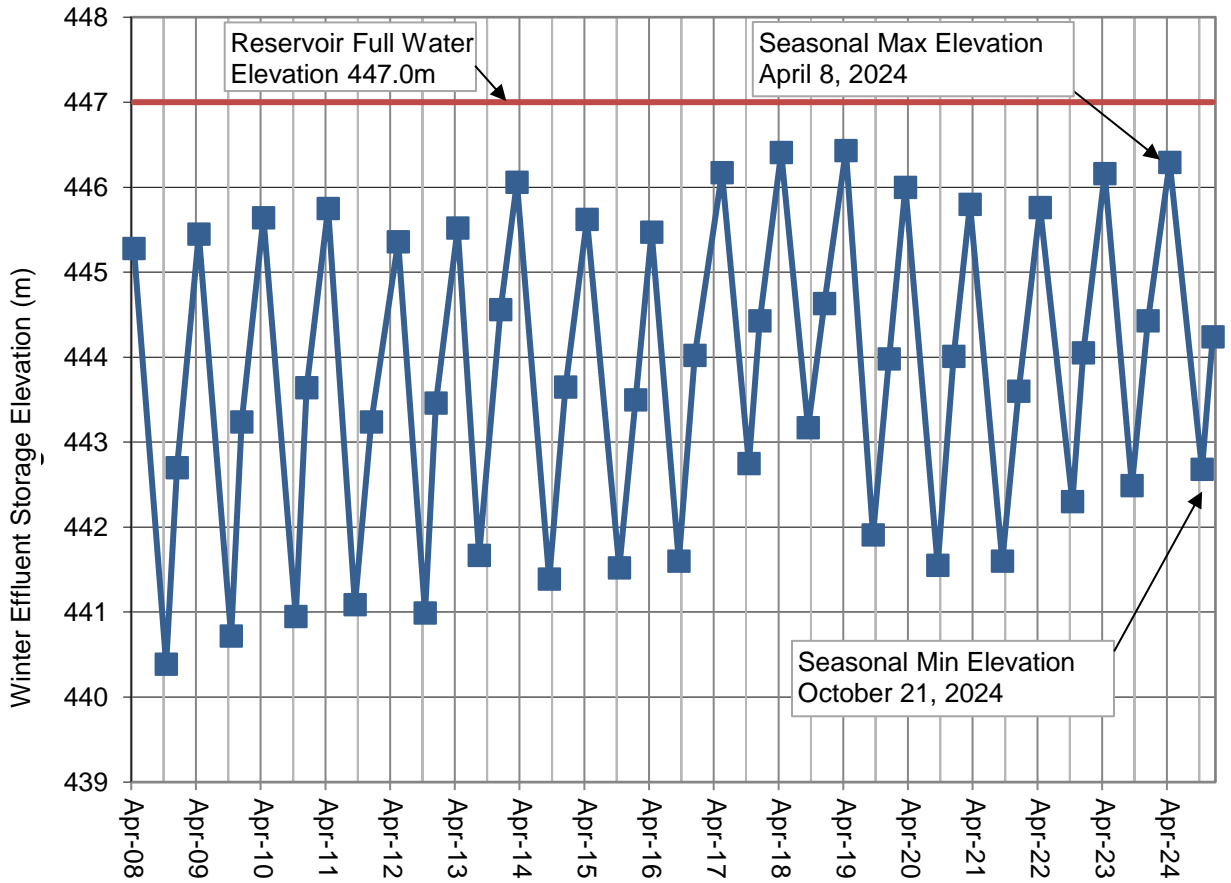
FIGURE 1-5: EFFLUENT STORAGE RESERVOIR LEVELS - 2008 TO 2024

- The maximum elevation in 2024 (446.29 masl on April 8<sup>th</sup>, 2024) is 0.13 metres above the 2023 maximum level.
- The 2024 year-end storage of 216,000 m<sup>3</sup> is 59,000 m<sup>3</sup> less than the 2023 storage at year-end.

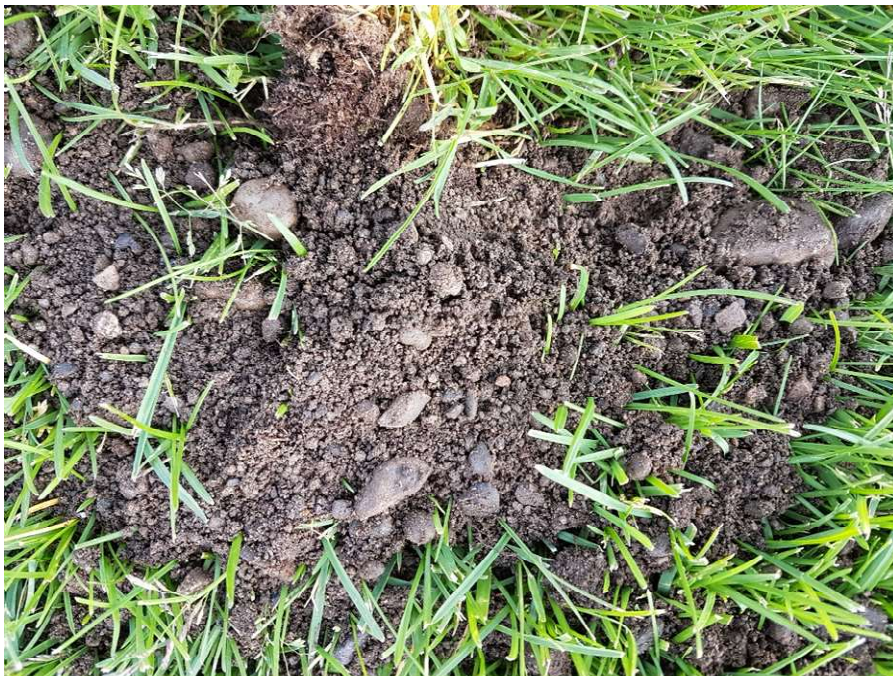
**Photo 2:** Typical surface soil (~4-20 cm below surface) at school site.

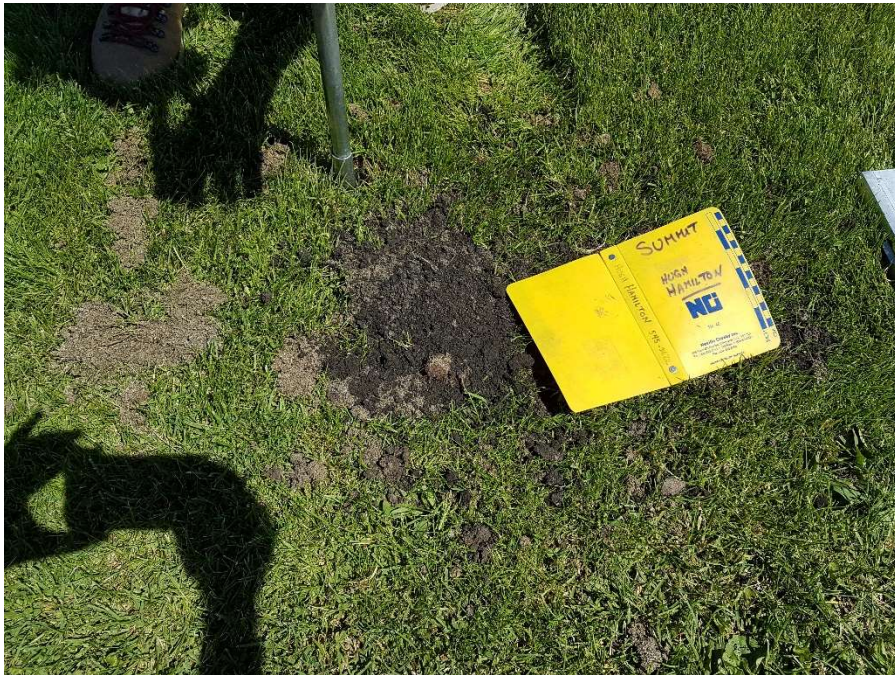
**Photo 6:** Example of silty soil in north part of Oliver Community Park

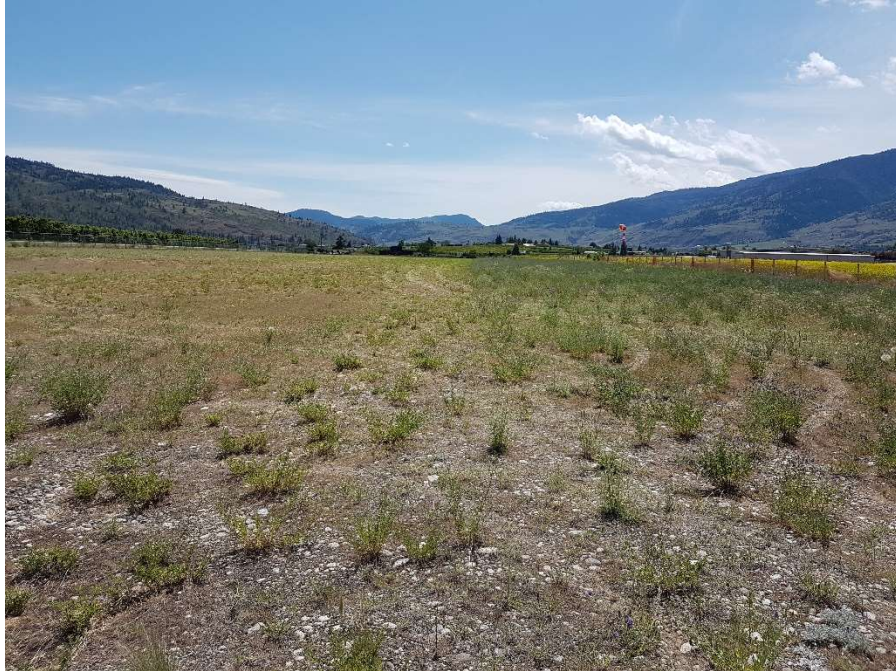
**Photo 7:** Proposed new irrigation area at airport. Note exposed sub-soil and relatively sparse vegetative cover [Land on right side of photo may receive some irrigation water from fields near runway (yellow flowers)].

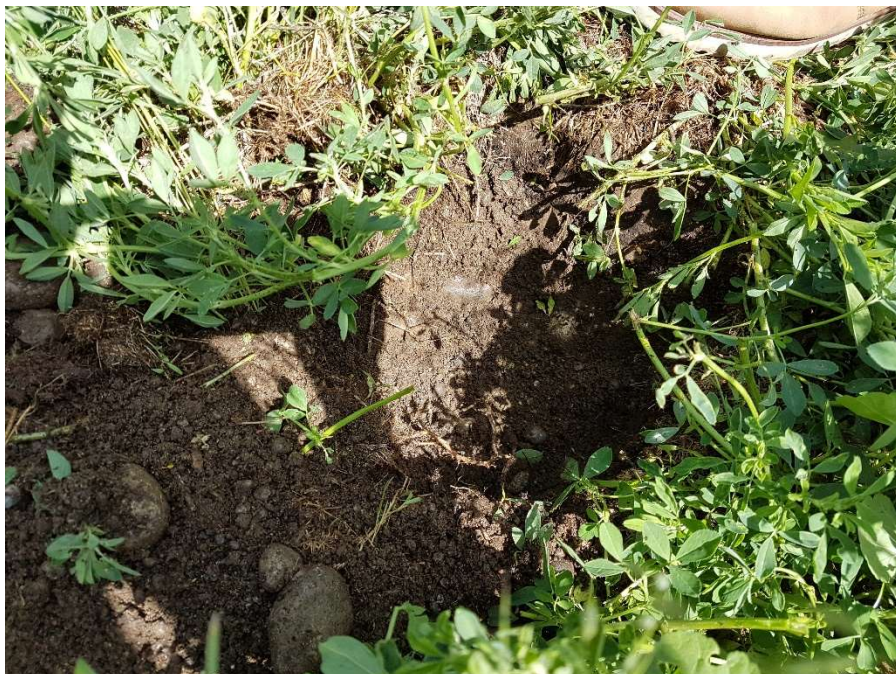
**Photo 8:** Surface soil in irrigated fields. Note intact dark upper horizon and presence of gravel throughout.

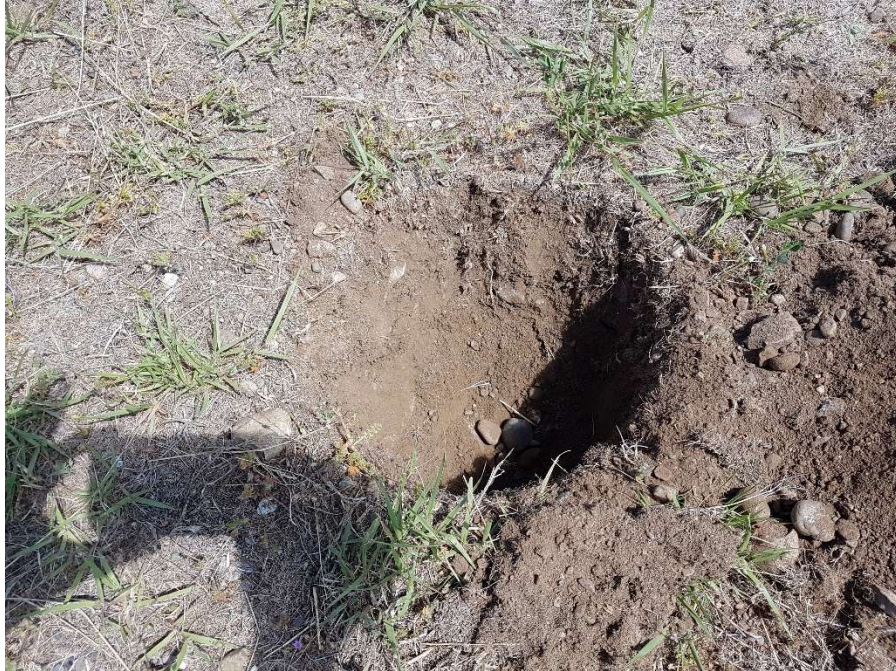
**Photo 9:** Soil pit on proposed irrigation area at airport. At this location, a residual A/Ap horizon is present. Note fine roots in upper 10 cm.

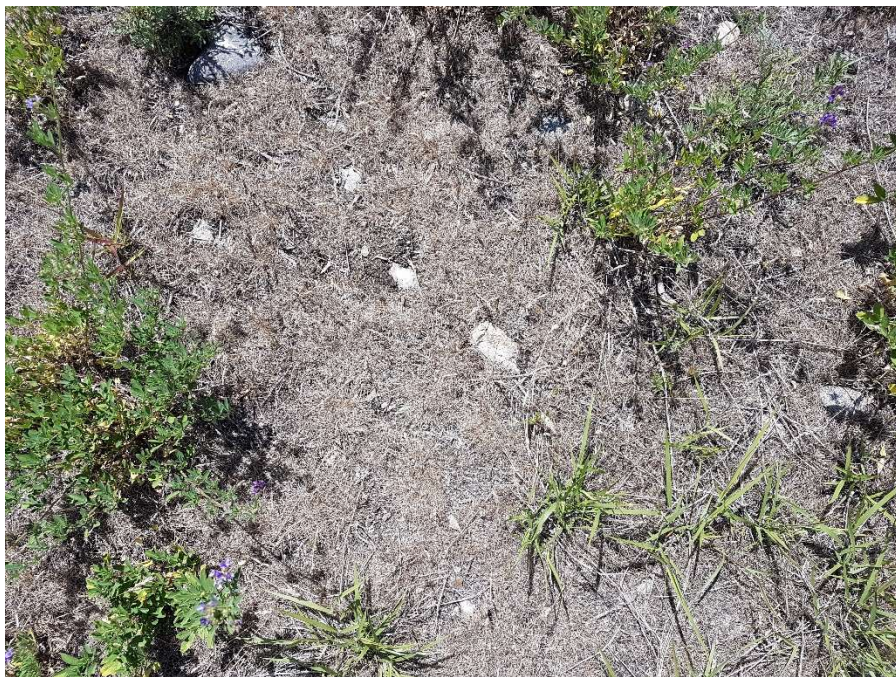
**Photo 10:** Ground surface at new airport irrigation area where topsoil may have been partially removed. Note how alfalfa plants are green as their roots obtain moisture from deep within soil.

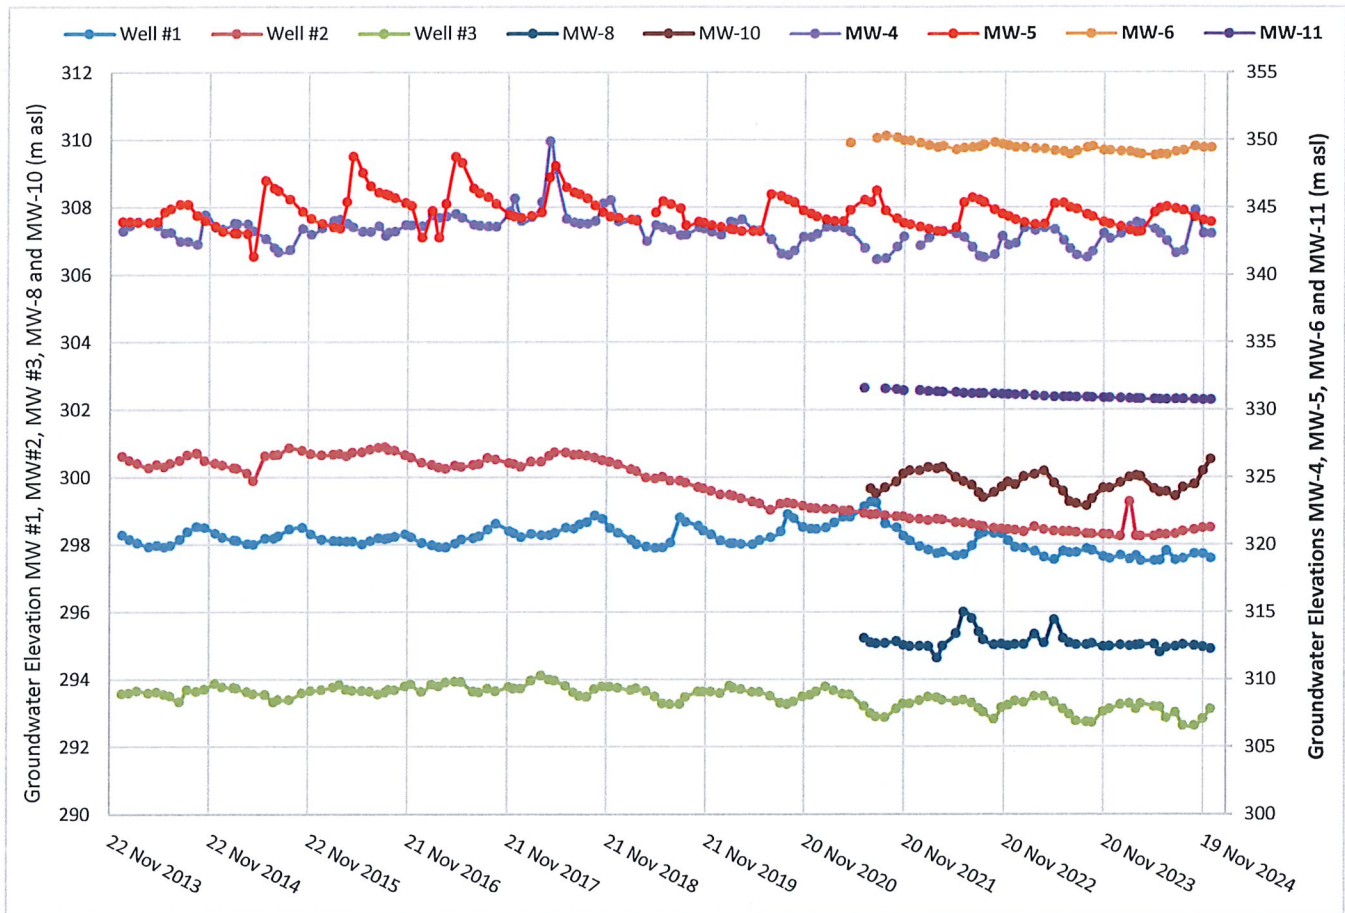
**Figure 2.1 Groundwater Elevation Hydrograph of Oliver Groundwater Monitoring Wells**

Water levels collected at Well #1 and Well #2 in 2023 (except March 2023) and partially in 2022 were below the measured well depths. As water quality samples were collected in both April and September 2023 (and 2022), when water levels were measured below the well depth, the depth of both Well #1 and Well #2 should be reconfirmed by Town staff at the next monitoring event, referenced from top of PVC casing.
