Sanitary Sewer System 2019 Annual Report

Town of Oliver

February 2020

Project No. 306-088-007

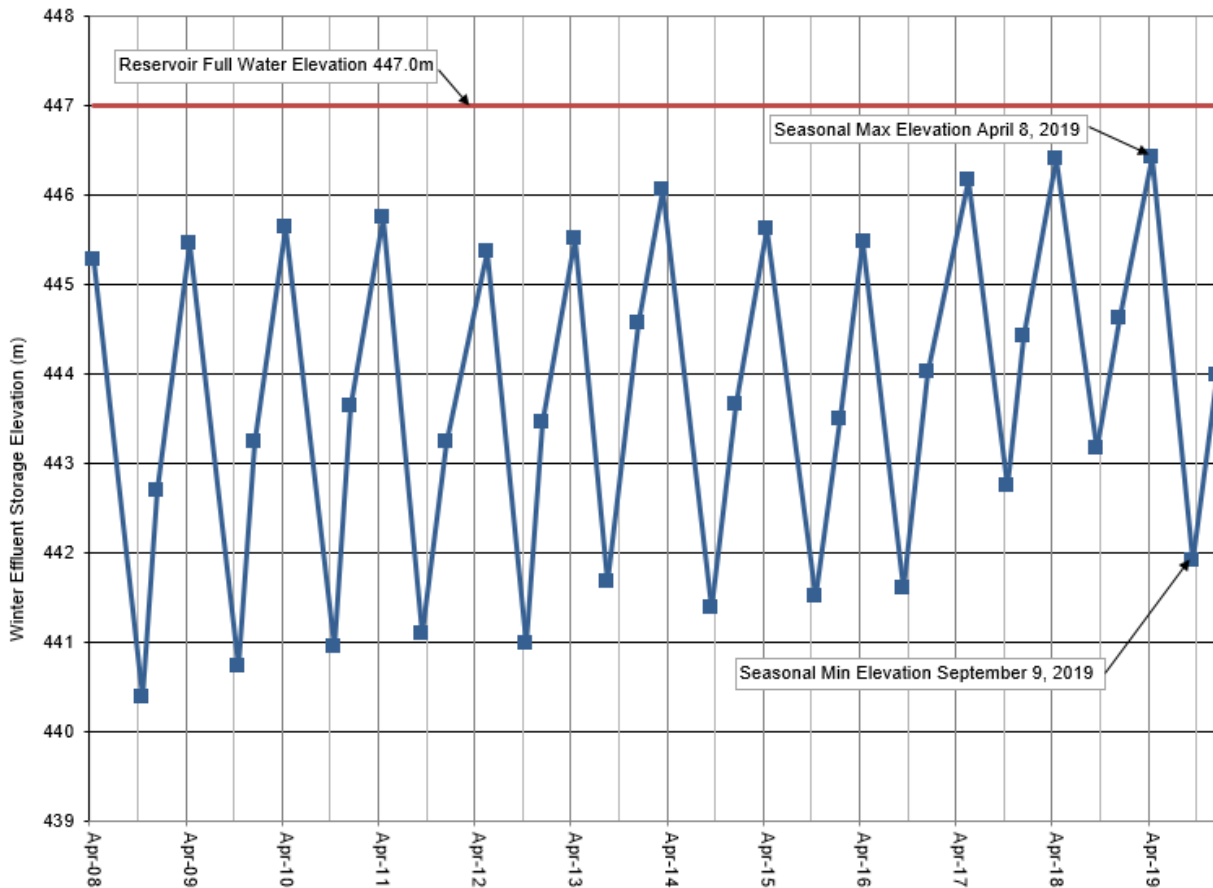
FIGURE 1-4: EFFLUENT STORAGE RESERVOIR LEVELS FOR 2008 TO 2019

- The maximum elevation for 2019 (446.43 m on April 8, 2019) is the highest observed in the 12-year period of record.
- The 2019-year end volume in storage of 245,000 m³ is 44,000 m³ less than end of year storage in 2018.
